**UNITED STATES OF AMERICA
BEFORE THE
FEDERAL ENERGY REGULATORY COMMISSION**

Séliš Ksanka Qíispé Project

Project No. 5-000

**ENERGY KEEPERS, INCORPORATED'S AND THE CONFEDERATED SALISH AND
KOOTENAI TRIBES OF THE FLATHEAD RESERVATION'S RESPONSE TO
NATIONAL ORGANIZATION TO SAVE FLATHEAD LAKE'S (NOSFL)
JANUARY 4 AND 5, 2024 REQUEST AND PETITION**

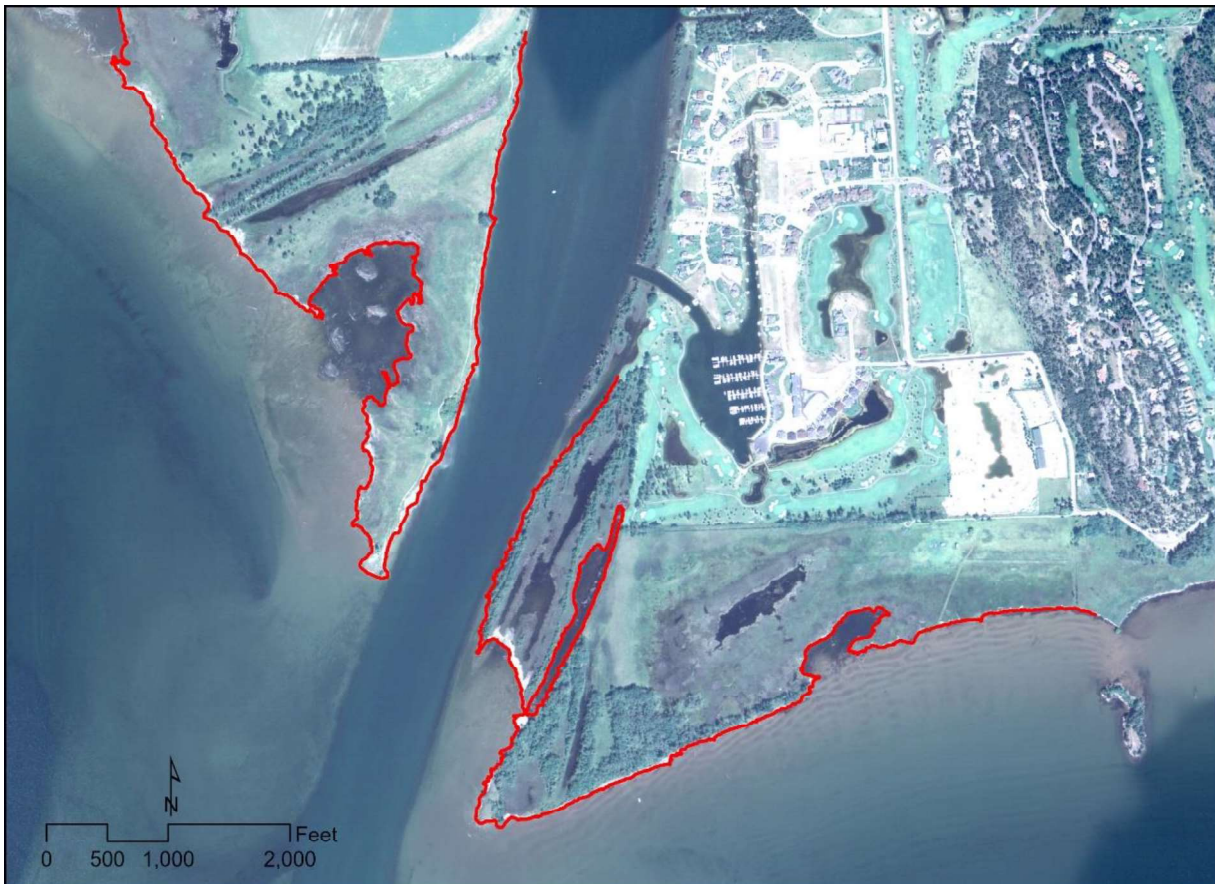
Figure 1. This is a 2005 MT Department of Natural Resources airborne NAIP image of the north shore showing the USFWS Waterfowl Production (WPA) prior to the construction of erosion control structures that began in 2007 along what is now the MTFWP Osprey Landing property (see figure 4). The red line is the shoreline at that time and represents the limit of shoreline loss prior to construction of the both shore-attached, and offshore erosion control gravel beaches and gravel, large wood erosion control structures built to stop erosion to the WPA riverbanks. This line serves as a metric in the analysis of structure success in the 2016 and 2017 final reports to the *EKI* and are included in this final report. Success is defined then as maintaining this shoreline position. Construction of erosion control structures started in 2007 on the eastern edge of the WPA extending to the river mouth in 2009. Construction of erosion control structures was completed for both sides of the river mouth by 2012.

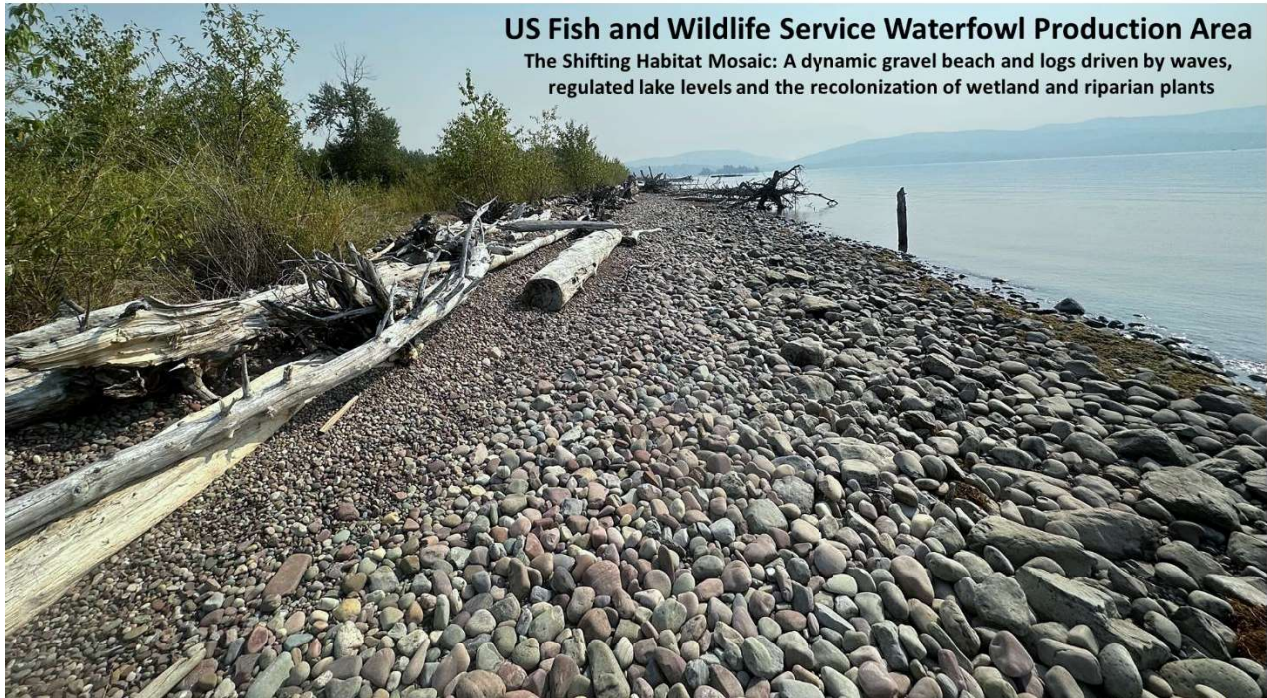
Figure 6. This photograph is of the gravel beach located near piling G (see figure 9) on the lakeward side of the offshore structure on the east side of the river mouth. The river brings logs into the lake that disperse as a function of currents and waves. Waves push the logs ashore and then rework and sort the gravel creating a gradation in size from coarse cobbles lakeward where wave-breaking processes occur to finer gravel, logs and woody debris forming the shoreline against the vegetated bank. This dynamic gravel beach zone is where waves and regulated lake levels coupled with recolonization of wetland and riparian plants work together to form a constantly shifting mosaic of shoreline habitat. These processes maintain an important structural and functional outcome for a healthy nearshore ecosystem in Flathead Lake just as they do in gravel-bed rivers (*sensu*, Stanford, Lorang and Hauer 2005).

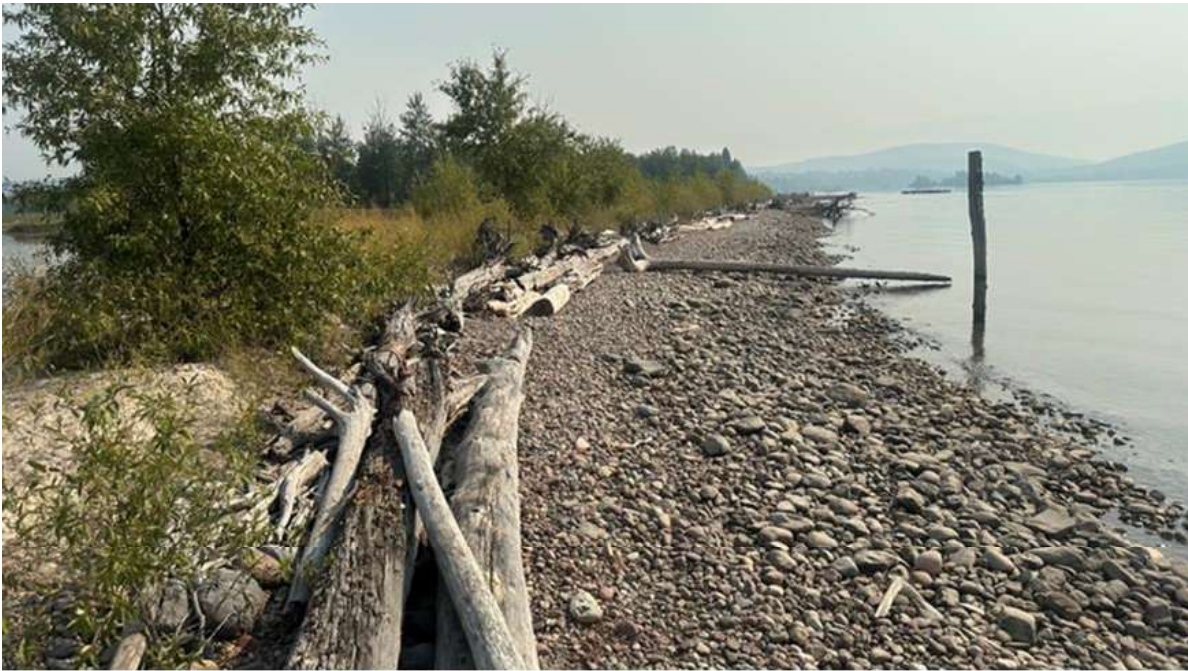
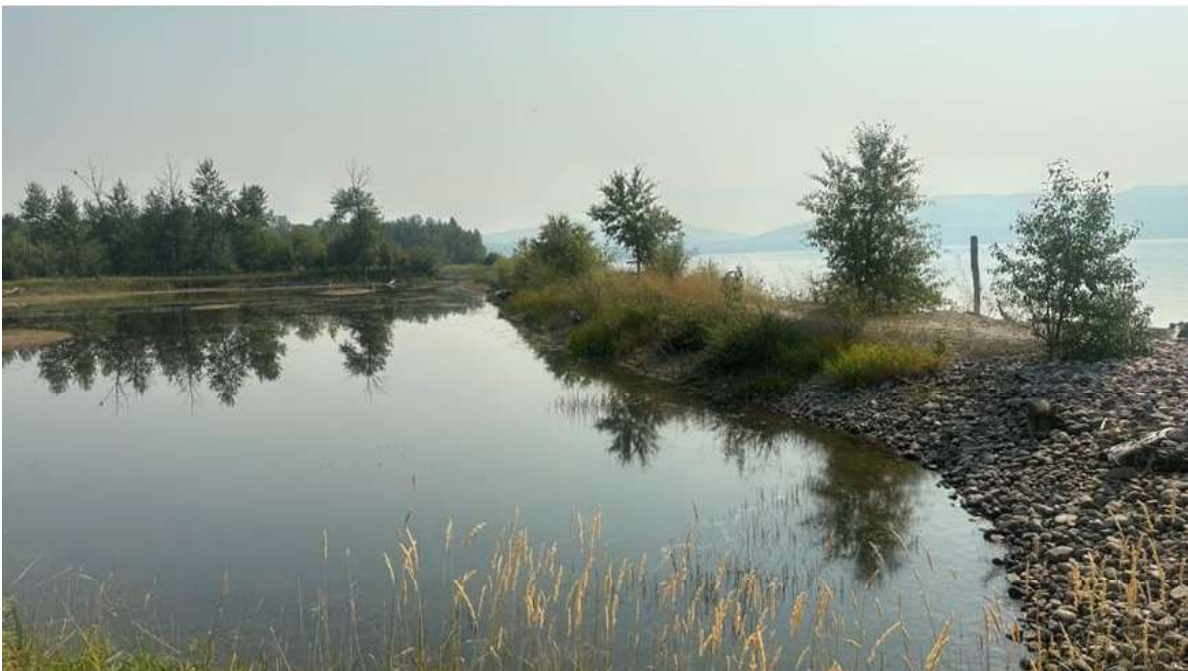
Figure 7. These photographs show the dynamic gravel beach on the lakeward side of the offshore gravel bank (top near piling G) compared with the inside shoreline of the gravel bank that is not exposed to wave action (bottom). Piling G corresponds to Transect G where survey data were extracted from the 2017 Lidar DEM and the 2016 and 2023 DSM.

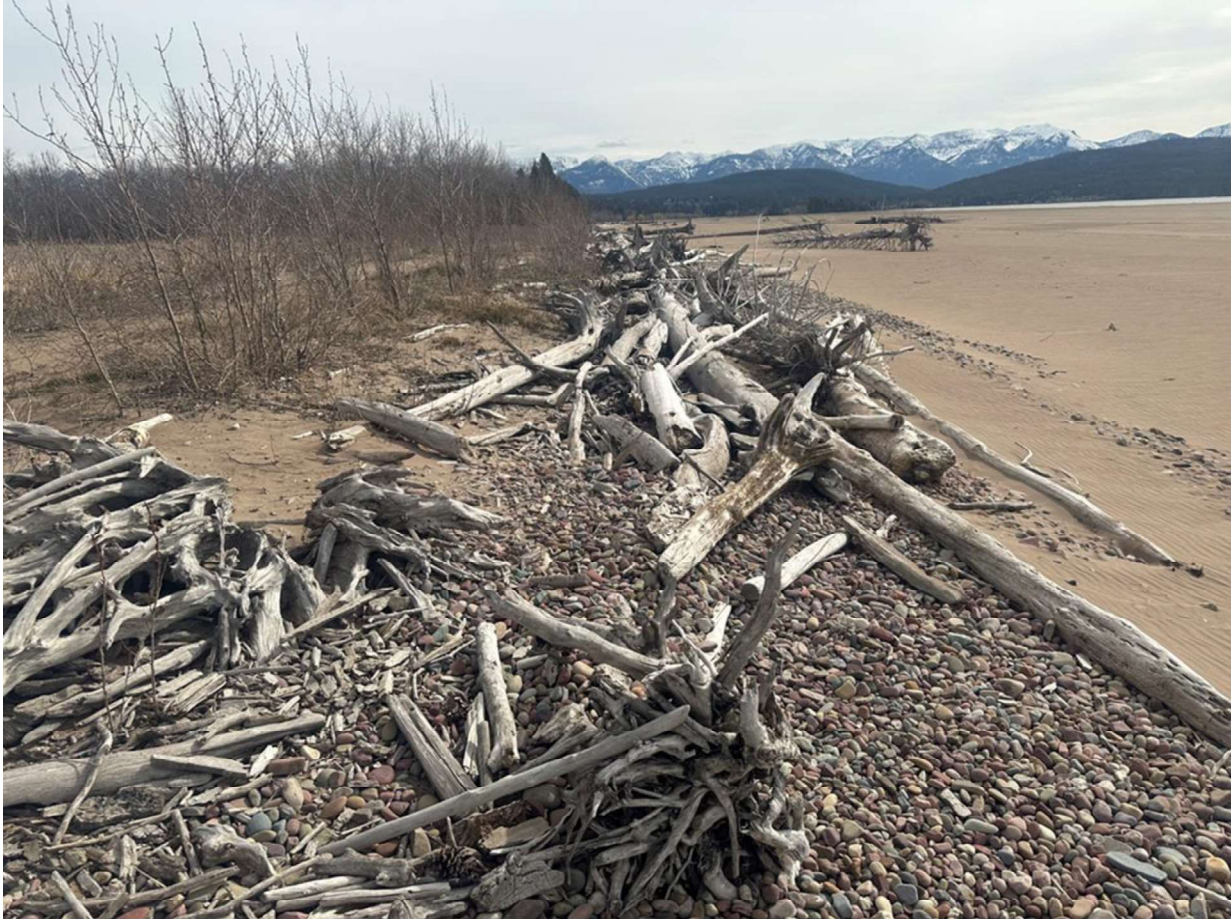
Figure 8. This photograph shows windblown sand deposited on to the exposed gravel beach and backshore of the bank. This process occurs in the spring during lake drawdown and is an important component in the shifting habitat mosaic of the WPA shoreline.

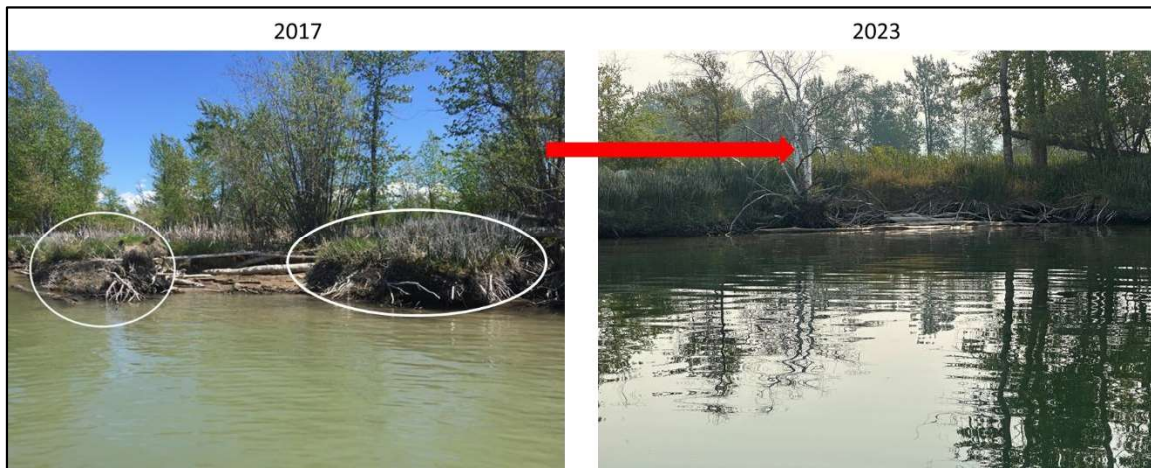
Figure 12. These photographs show erosion of the natural levee above the WPA (see figure 5 for location). The one on the left is from 2017 and on the right from 2023. The red arrow points to a tree common to both photographs. The white circles show the collapsed bank in 2017 that has been completely washed away and now the birch tree that the red arrow points to in the 2023 photograph has become undercut by wind-waves, boat wakes and river currents. This process will continue allowing water and fish to freely reach the water behind the offshore dike.

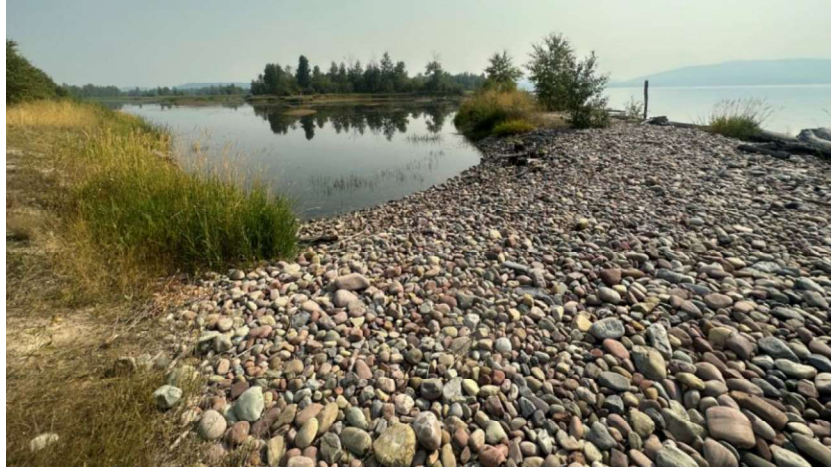
Figure 13. This 2023 photograph shows the cobble-barrier near the spit. It prevents northern pike from accessing the back water and using it for spawning. This barrier also severely limits the exchange of water. Water behind the dike becomes very warm in the summer creating a water quality issue for the lake and limiting the regrowth of aquatic and wetland plants. This cobble material should be removed and allow fisherman to harvest north pike as a means of controlling their population.

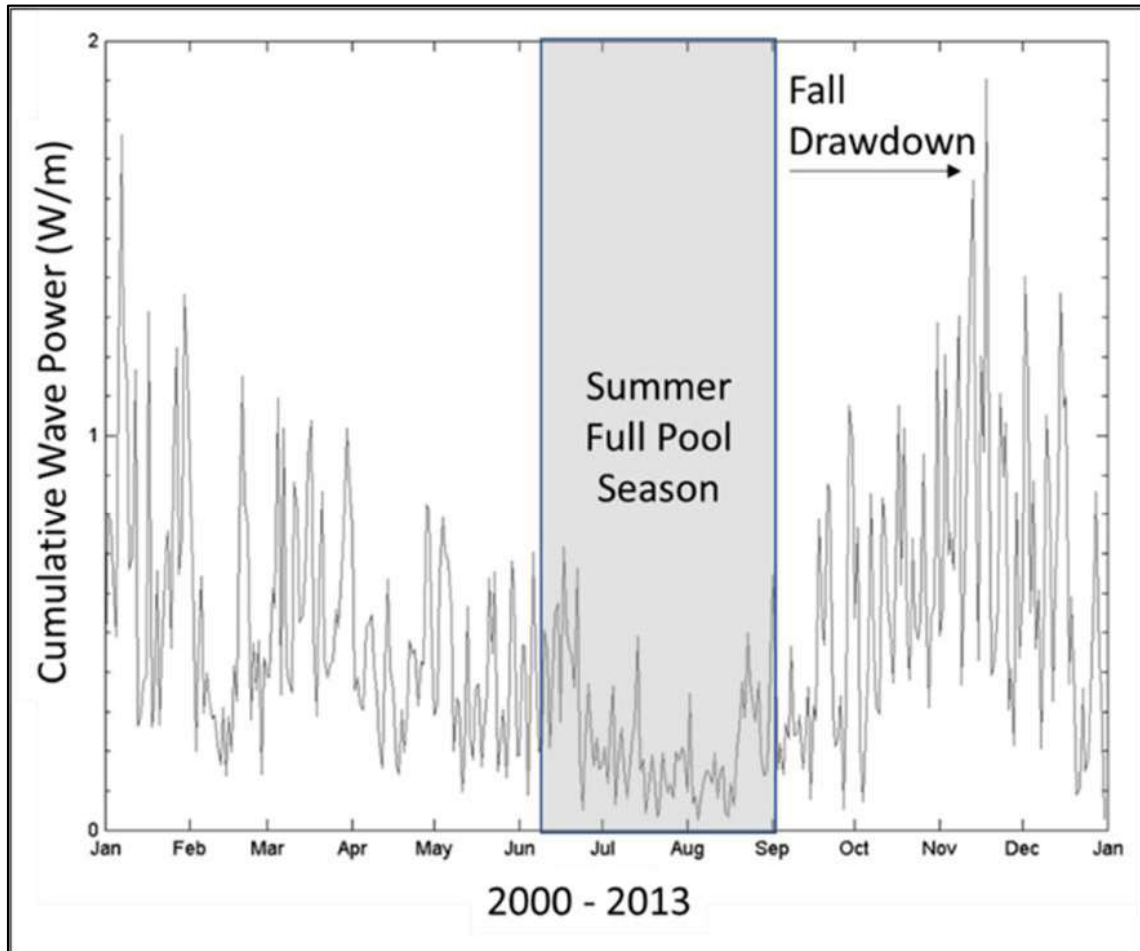
Figure 15. This schematic is a plot of cumulative wave power calculated on 15-minute intervals over the years 2000 to 2013 defines seasonality in the magnitude of storms. Summer Full Pool season has the lowest wave power compared to fall and winter. This graph provided information to the power companies that lowering the lake level in the fall would help reduce wave erosion lake wide.

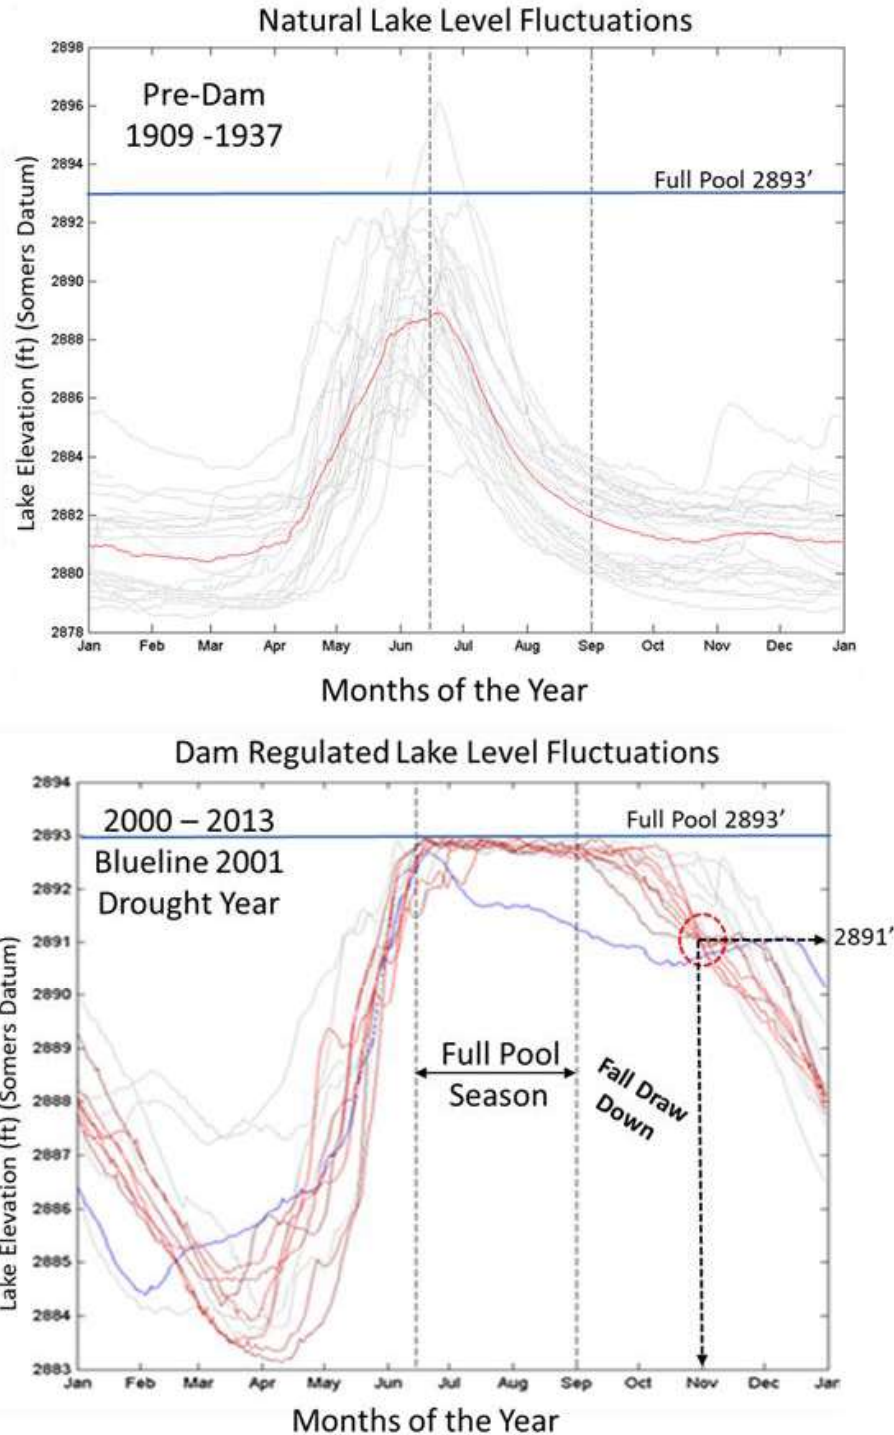
Figure 16. These two panel plots compare nature lake level fluctuations (top panel) to dam regulated lake levels (bottom panel). The decision was made in 2007 to draw down the lake level after Labor Day to an elevation of 2891' by November 1 (red lines). The grey lines show lake regulation from 2000 to 2006. During this maximum erosion period the dam operators regulated the lake with little regard for the harmful effects of wave erosion. The period of erosion mitigation (2007 to 2013) was an attempt to reduce wave erosion from fall storms lake wide by lowering the lake.

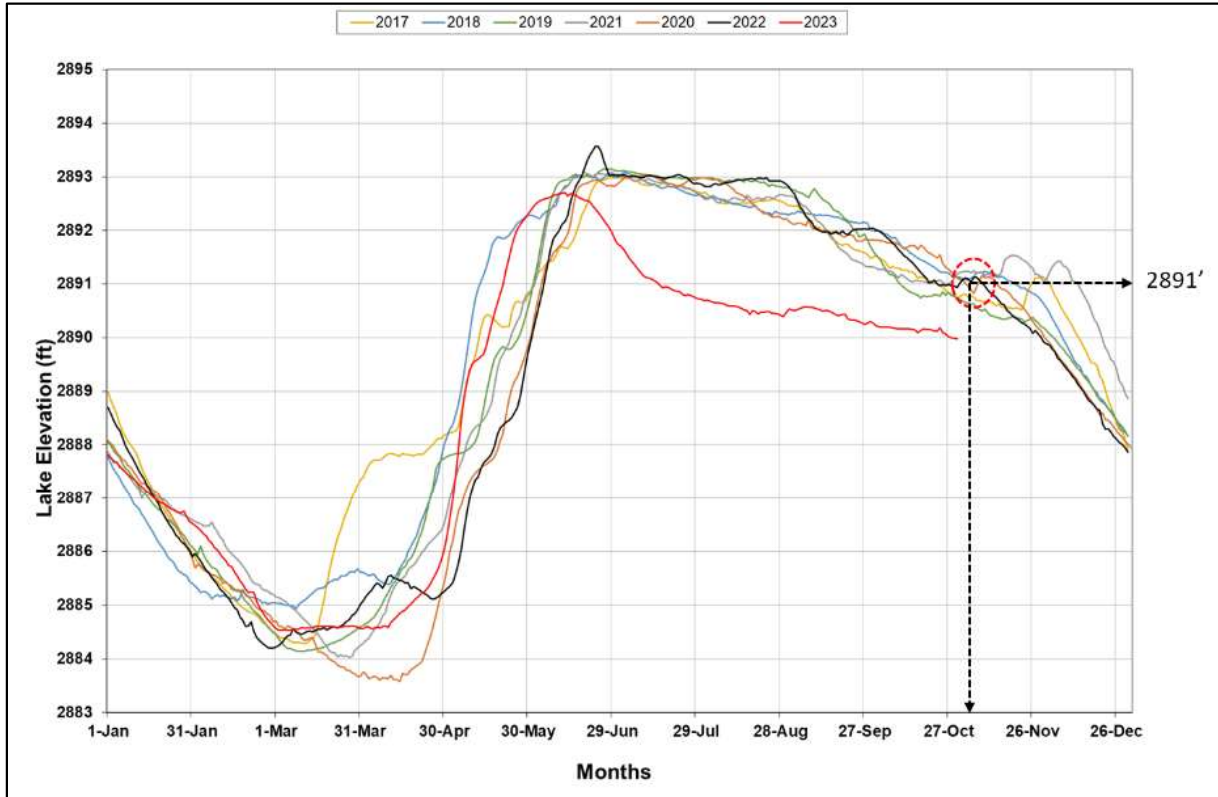
Figure 17. This line graph shows lake level regulation under dam operations by Energy Keepers Inc. Their approach is to bring the lake up to 2893' by June 15th as contractually obligated. This can only happen if the watershed delivers enough water. Both drought years, 2001 (blue line figure 16 bottom panel) and 2023, the watershed did not deliver enough water to fill Flathead Lake to 2893' by June 15th. EKI starts an early drawdown beginning soon after June 15th to 2891' by November 1, except for the 2023 drought year when the lake hit 2891' by end of June. The 2023 hydrograph shape is much closer to the mean lake level change occurring under natural un-regulated lake levels (Fig. 16 top panel) which greatly reduces wave erosion and harm caused the nearshore zone of Flathead Lake.

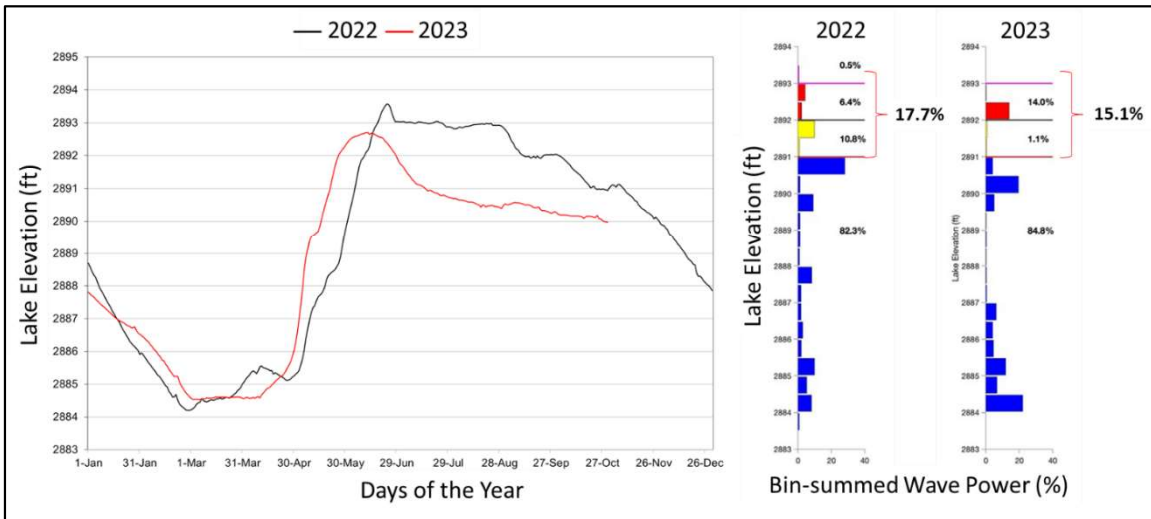
Figure 18. This panel graph shows lake level regulation under dam operations by Energy Keepers Inc. for the two years that span the lake level regulated regime since dam operation began in 1938 (left panel). The 2022 freshet release of water exceeded the capability of the dam to release water and keep the lake from exceeding 2893' (bump in the black line). The vertical distribution of wave power above 2891' was very similar, 17.7% versus 15.1% for each year and considerably less than the previous two decades of lake level regulation that distributed 67% and 31% of the wave power above 2891 ft.

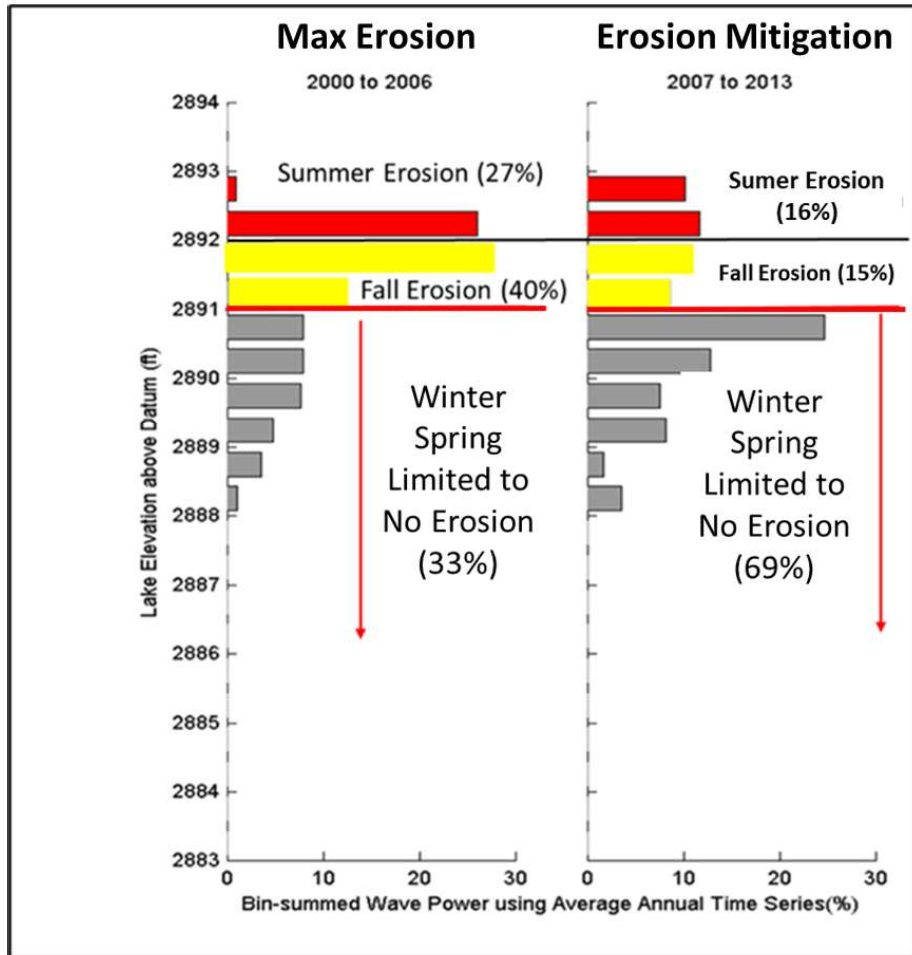
Figure 19. These two panel graphs show histograms of how different dam operations vertically distributed wave power corresponding to lake level regimes shown in figure 16. The graph on the left panel corresponds to the lake level regimes described as the maximum wave erosion period because fall storms were not a concern. During 2000-2006 67% of the annual wave power was focused on lake levels that create the most erosion. From 2007 to 2013 the power company became aware that wave erosion could be decreased by drawing the lake down to 2891 ft before the fall storms hit. That six-year regime resulted in 31% of the annual wave power being focused on lake levels that creates the most erosion. This erosion mitigation period saw > 50% reduction in wave power compared with the maximum wave erosion period.

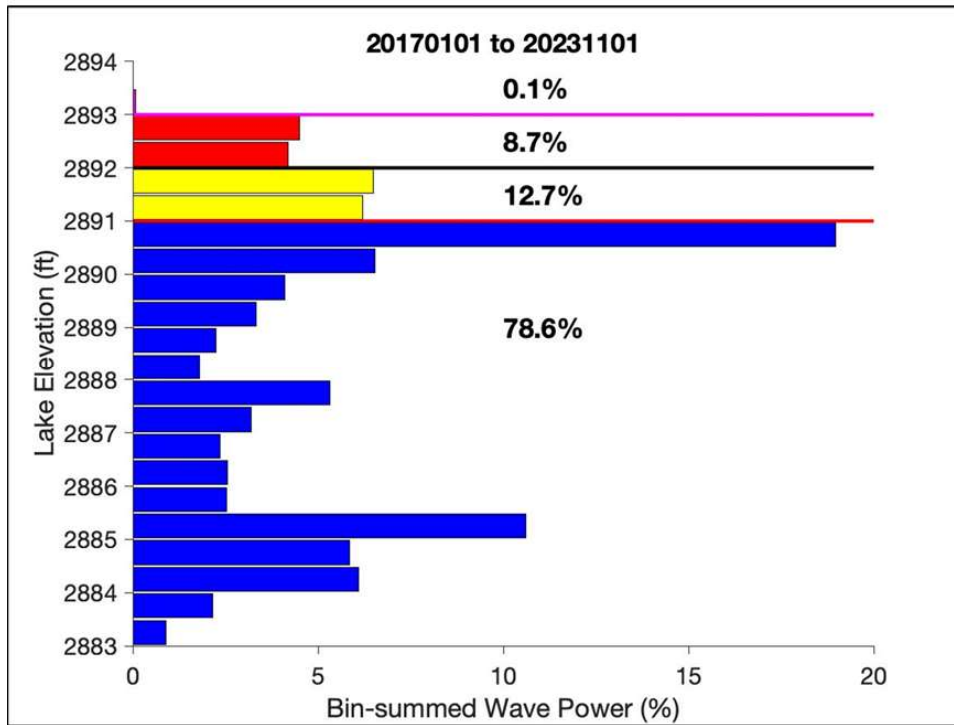
Figure 20. This histogram shows the vertical distribution of wave power over the past 6 years Energy Keepers Inc. have operated SKQ dam. They reduced wave power that causes erosion to 21.5% compared to 31% and 67% of wave power that previous dam operations concentrated at erosion levels (red and yellow bars). EKI does this to reduce harm caused by dam operations to the nearshore zone of Flathead Lake while also reducing harm to the lower river while creating profit for the CSKT people, in keeping with their mission.

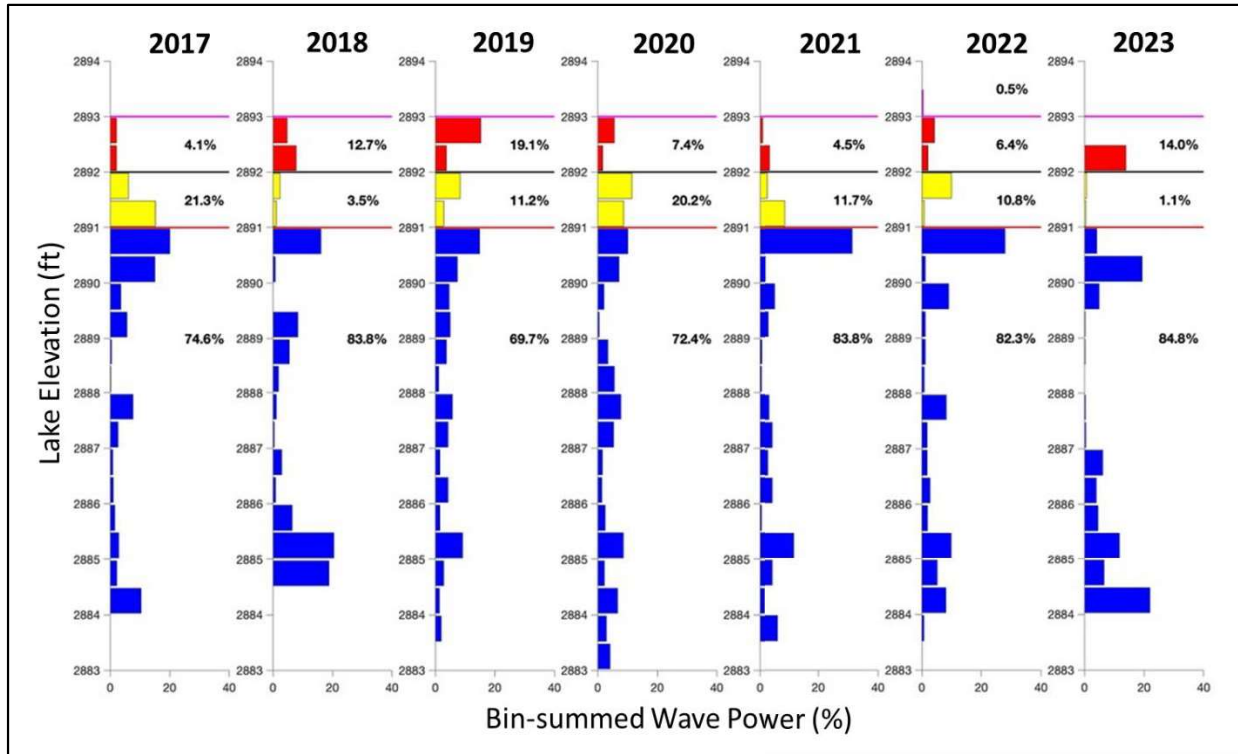
Figure 22. These seven panel graphs show histograms of how different dam operations vertically distributed wave power relative to the occurrence of wave events figure 21. The yellow and red bars indicate wave power that results in wave erosion.

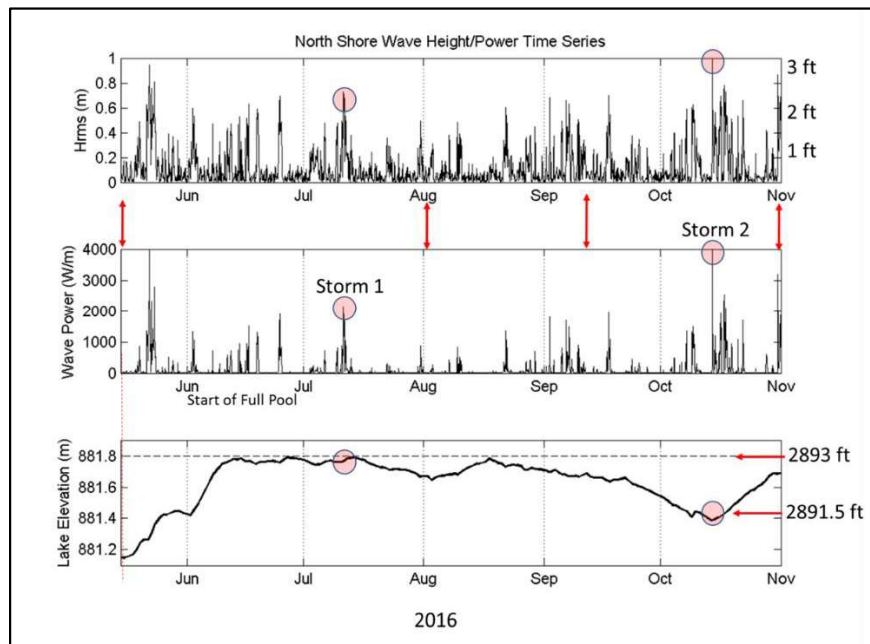
Figure 23. These three panel graphs are for the first year of *EKI* operation (2016). Two storm events have been identified that correspond to foot-surveys conducted that year at the upper and lower limits for erosive wave power quantified in figures 18-20 & 22.

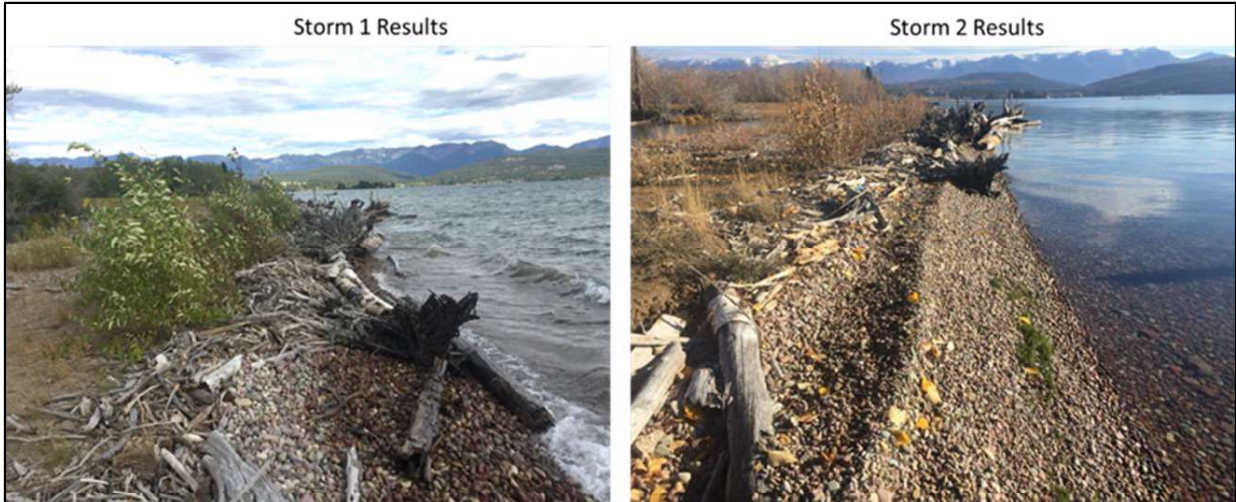
Figure 24. These two photographs show the beach’s response to waves associated with the storms identified in figure 23. The photo on the left is from a storm occurring very close to full pool lake level of 2893’ and shows how far waves reached up the beach and into the riparian plants trying to advance lakeward. The photo on the right shows how a lower lake level created the situation where larger storms with significantly more wave power could not reach up into the riparian fringe of the gravel dike.

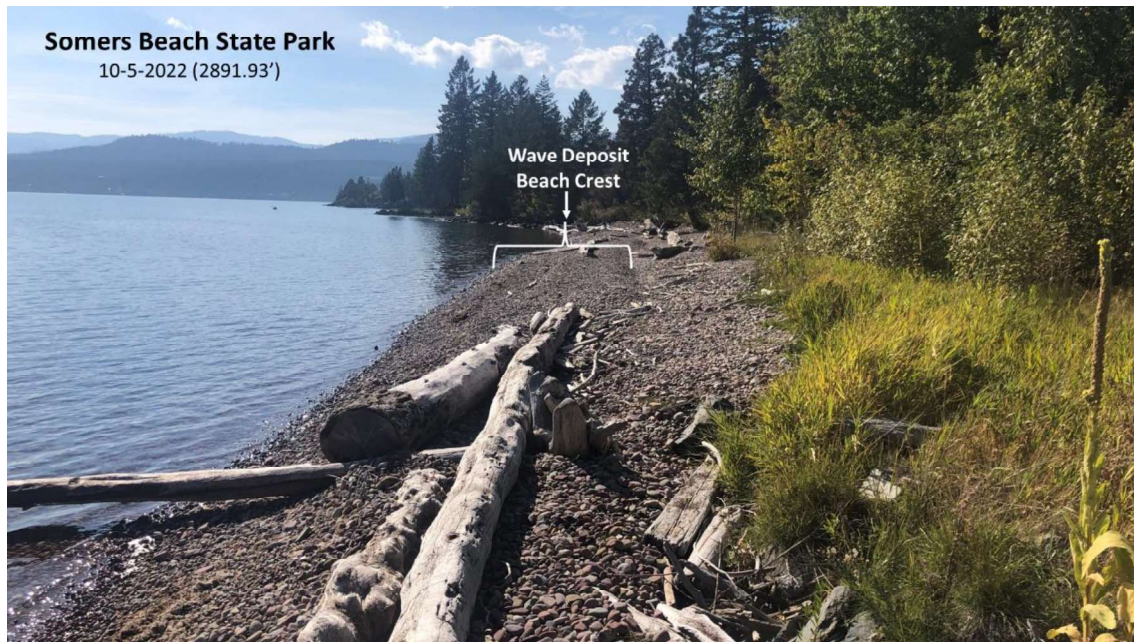
Figure 27. This photograph is of the swimming beach at Somers Beach State Park that corresponds to the survey data shown in figure 26. That material reworked by waves and deposited on top of the constructed beach material is identified by the white bracket which is the beach crest shown in figure 26. This beach crest is the product of the 2022 season of wave power shown in figures 22 & 25.

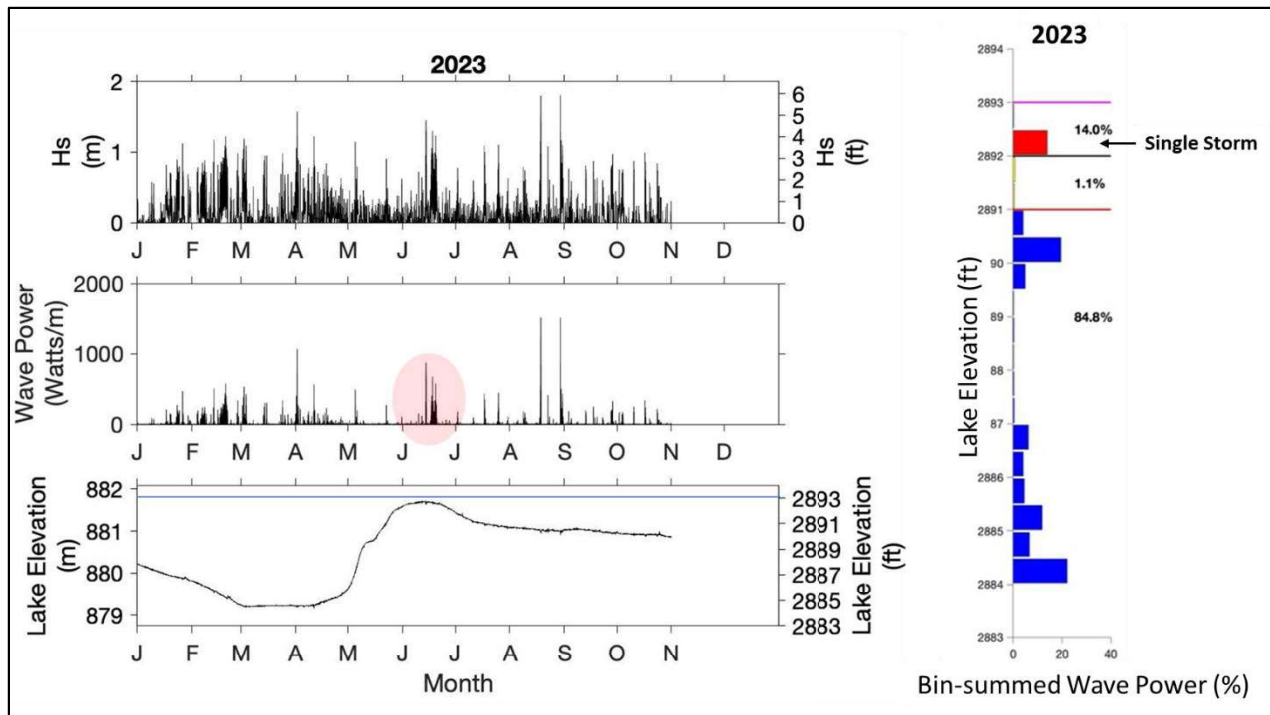
Figure 28. The panel graph on the left shows the occurrence of wave events relative to regulated lake levels during 2023 and the panel graph on the right shows the resultant vertical distribution of wave power due to the occurrence of storms relative to lake level. The single storm event (red circle) in the left panel is responsible for 14% of the annual wave power, through October 2023. Figures 29 to 32 depict the response of the gravel beach and the fringing wetland marsh to the combined 2022 and 2023 vertical distribution of wave power as controlled by lake level regulation.

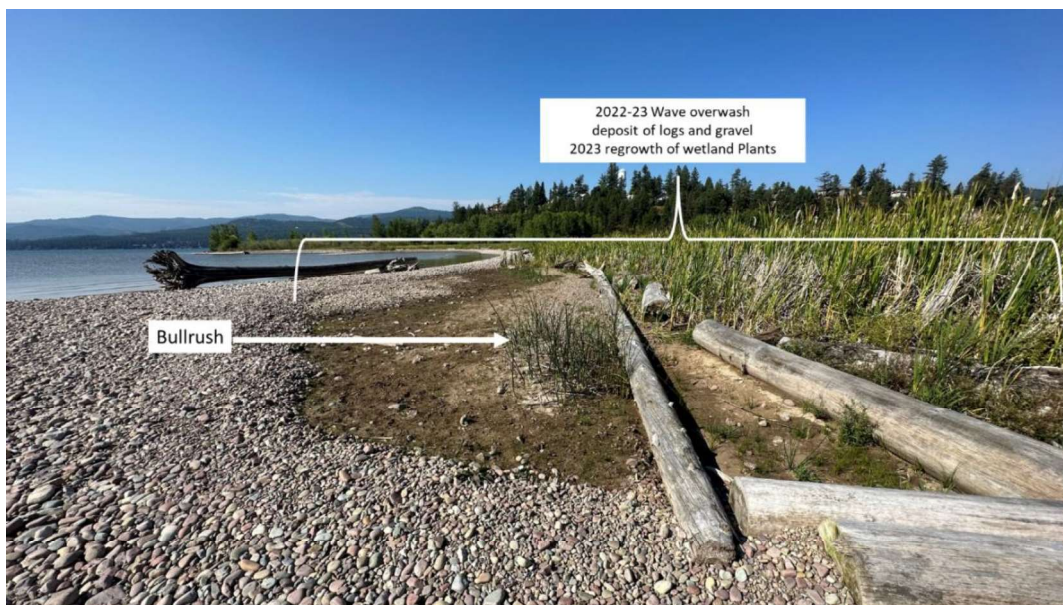
Figure 29. This photograph shows the results of two years of wave overwash processes that are coupled to the vegetative response.

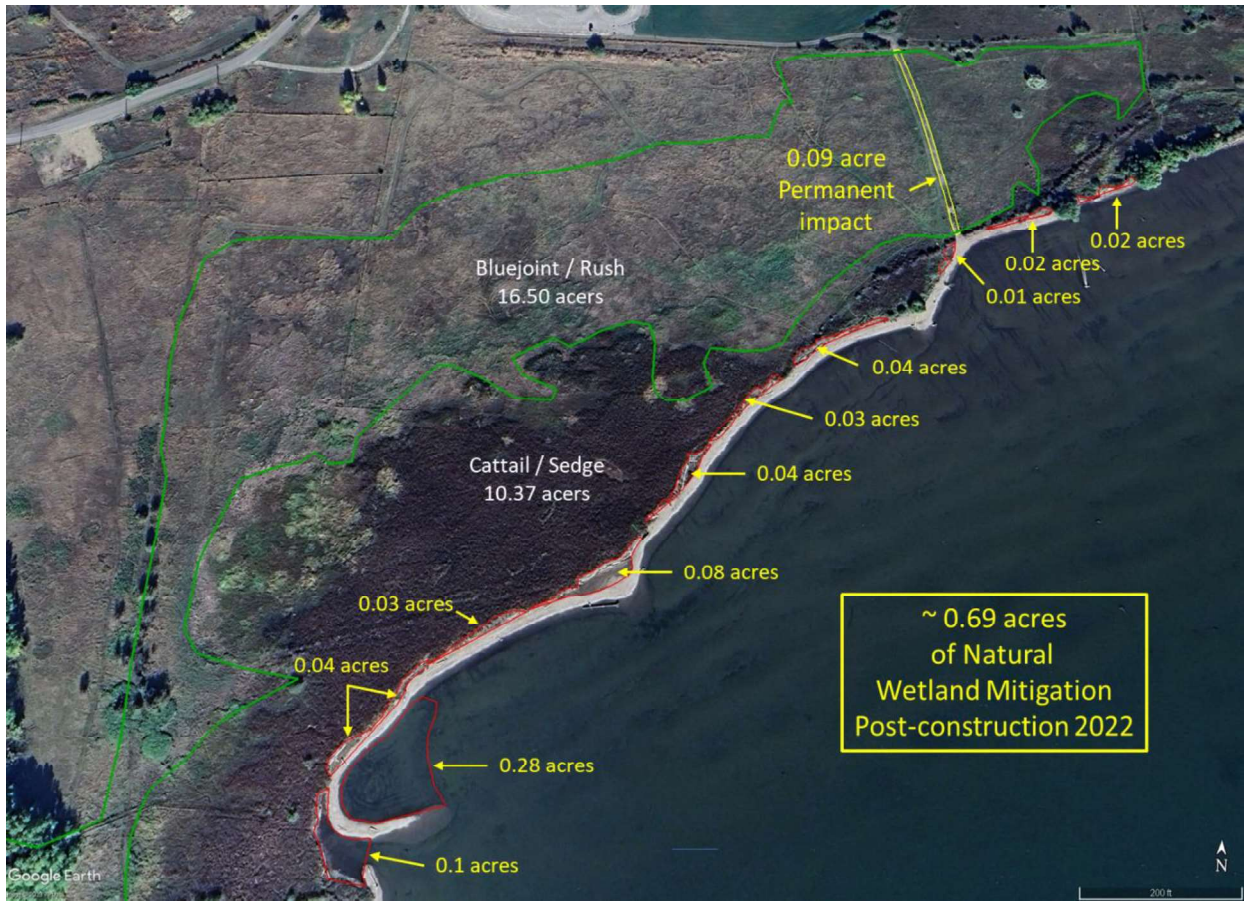
Figure 32. This aerial image from Google Earth (10-3-2023) shows the net regrowth of ~0.7 acres of aquatic and wetland habitat (red polygons) over the past two years (2022 and 2023). That vegetive response is directly related to lake level regulation in 2022 and 2023 and the occurrence of storm waves during that period followed by natural colonization of aquatic and riparian plants.

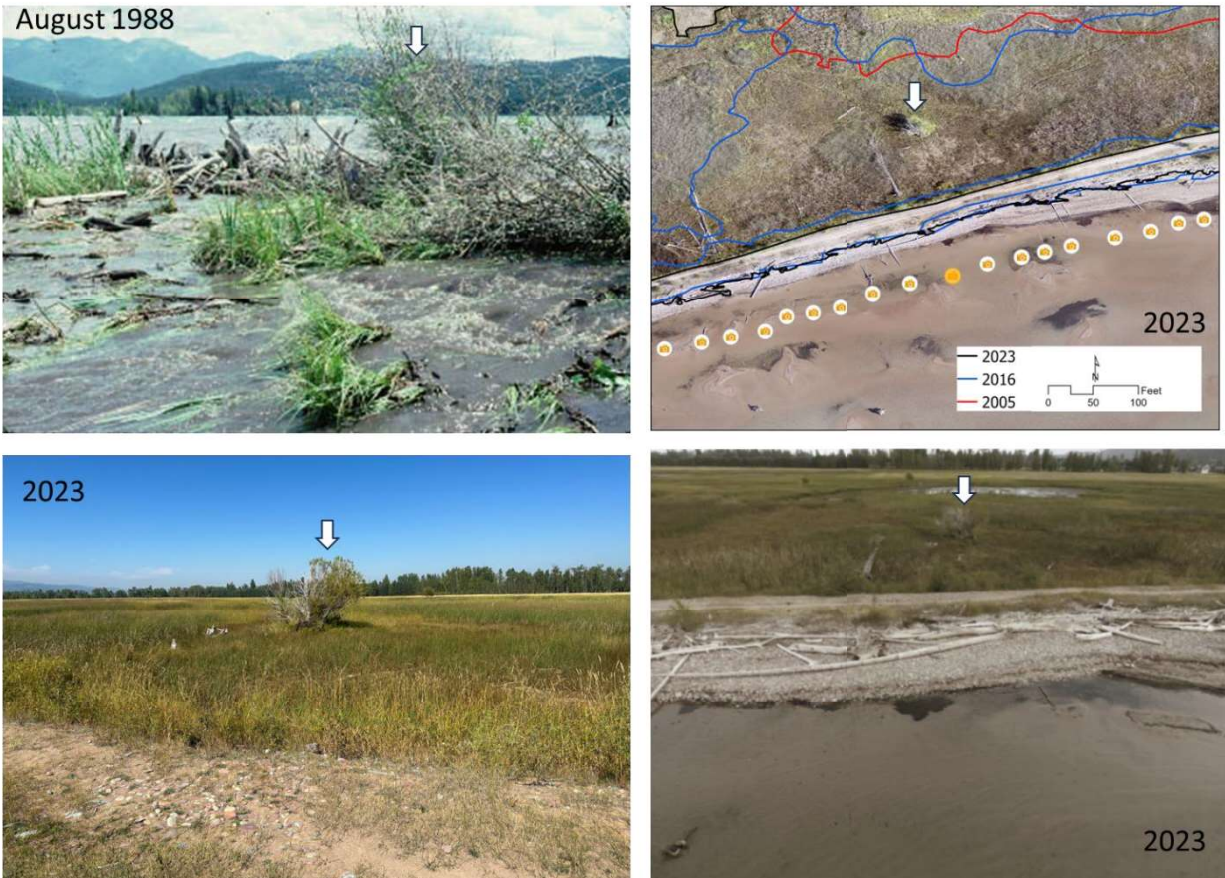
Figure 34. These four photographs are of the marsh area on the eastern portion of the WPA (far right black box in figure 33). The upper left is a photo of wave overwash process in action taken in 1988. The white arrow points to a Golden willow tree that was growing at the time in this location. It serves as a reference point in the following photos here and in other figures to aid in appreciation of the changes that have occurred. The photo in the upper right is a drone image with each photo icon linked within the ArcGIS database to the oblique images (orange dot). The photo in the lower right corner is the oblique image highlighted in orange dot in the upper right photo. The lower left photo is from the foot survey.

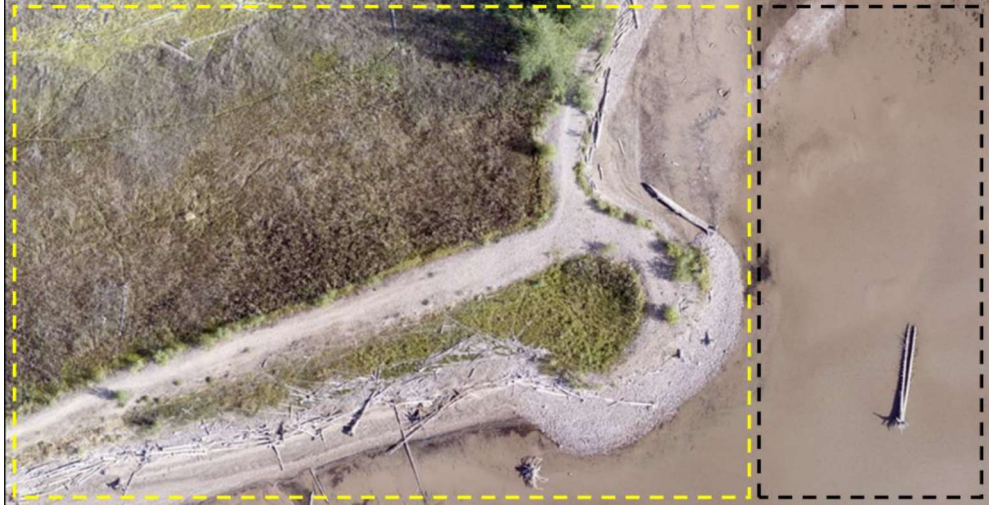
Figure 35. This aerial drone image taken in August 2023 photo shows a revegetated spit embayment and wetland complex behind it. The area in the yellow box looked just like the barren lakebed within the black box prior to construction of the gravel dikes. This photo area is shown as a yellow box in figure 36.

The WPA is a dynamic landscape dominated by a shifting mosaic of habitat that is changing from storm to storm and year to year. This process will continue long into the future especially given the way Energy Keepers Inc. have chosen to operate *SKQ* dam. How that can manifest into a healthy nearshore and wetland landscape is shown in figures 33 through 73. The starting point for appreciating and understanding the positive habitat change on the WPA is apparent when one compares how the barren lakebed in 2005 has evolved into new revegetated land (Figs. 34 & 35).

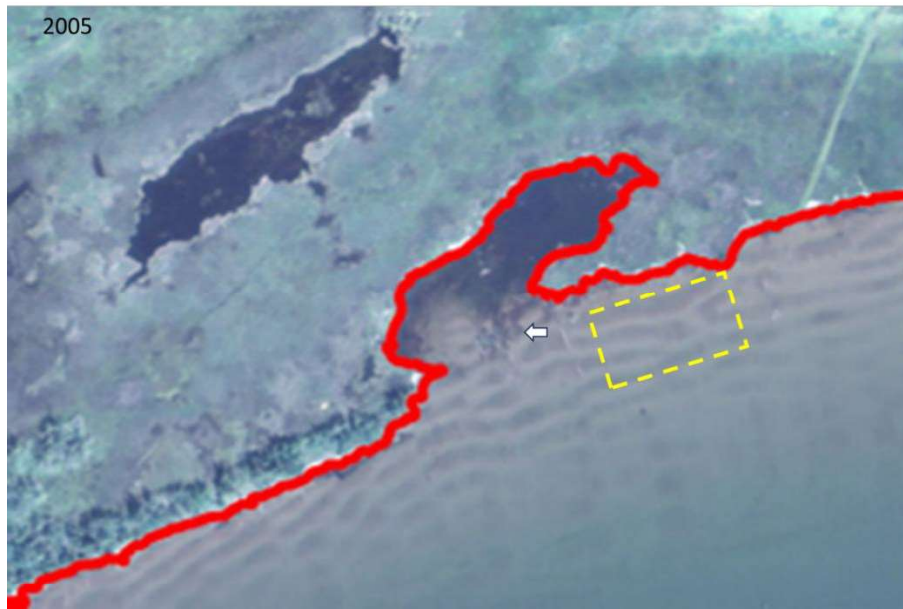
Figure 36. This is a 2005 aerial image of the area in the eastern most black box shown in figure 33. The yellow box shows the area outline for figure 35. The red line is the 2005 shoreline. The pond prior to 2005 was not connected to the lake (Fig. 34 upper left photo). The first breaching of the marsh shoreline occurred in 1988 and widened over the years eventually filling in the pond as shown in this 2005 aerial photograph. The fields of multiple bars play a crucial role in reducing wave erosion. They form due to a standing wave pattern that develops creating rhythmic repeated patterns of sand bars and troughs. Incident waves break on the bar crests and hence dissipate some of the wave energy as spilling breakers. During storms, waves breaking across these bars can extend hundreds of meters offshore. The white arrow shows the position of the golden willow that appears in other figures as a reference.
