**UNITED STATES OF AMERICA
BEFORE THE
FEDERAL ENERGY REGULATORY COMMISSION**

Séliš Ksanka Qíispé Project

Project No. 5-000

**ENERGY KEEPERS, INCORPORATED'S AND THE CONFEDERATED SALISH AND
KOOTENAI TRIBES OF THE FLATHEAD RESERVATION'S RESPONSE TO
NATIONAL ORGANIZATION TO SAVE FLATHEAD LAKE'S (NOSFL)
JANUARY 4 AND 5, 2024 REQUEST AND PETITION**

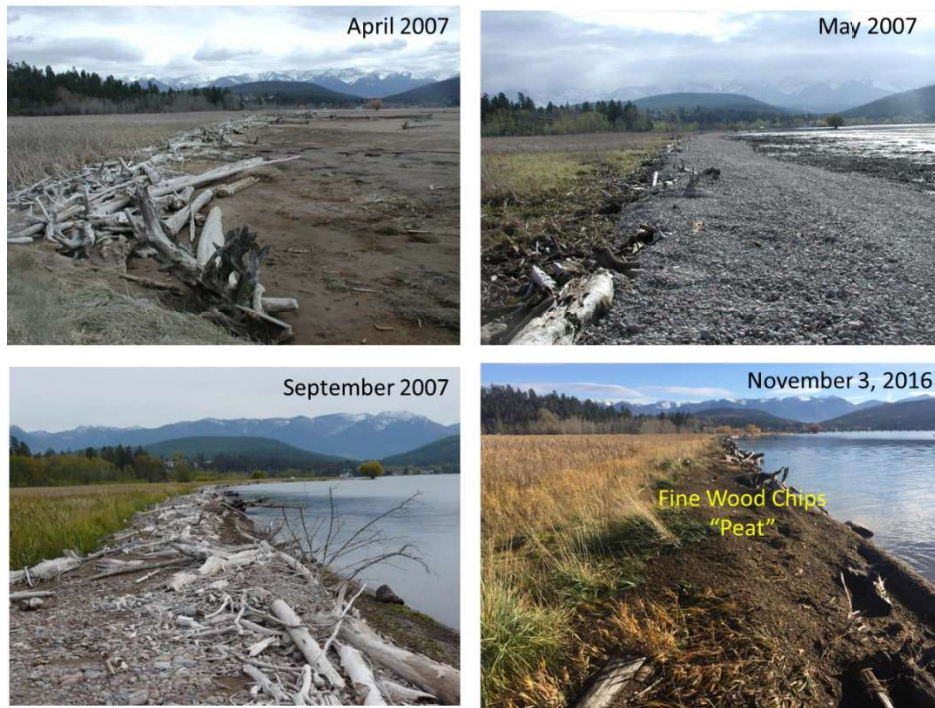
Figure 38. These four photographs show the shoreline from ground level that corresponds to the aerial views in figure 37. The upper left photo shows the condition of the shoreline in 2007 prior to construction of the beach. Overwash process would push the logs further into the marsh while eroding the mud bank/lakebed just lakeward of the logs. The upper right shows the finished gravel beach prior to lake level rise. The lower left shows the deposition of logs and woody debris on the gravel beach after the first full pool season. The photo in the lower right shows the condition of the shoreline in 2016. Fine wood chips and peat material deposited by wave action are mixed with windblown sand to create a perfect growing medium for wetland plants.

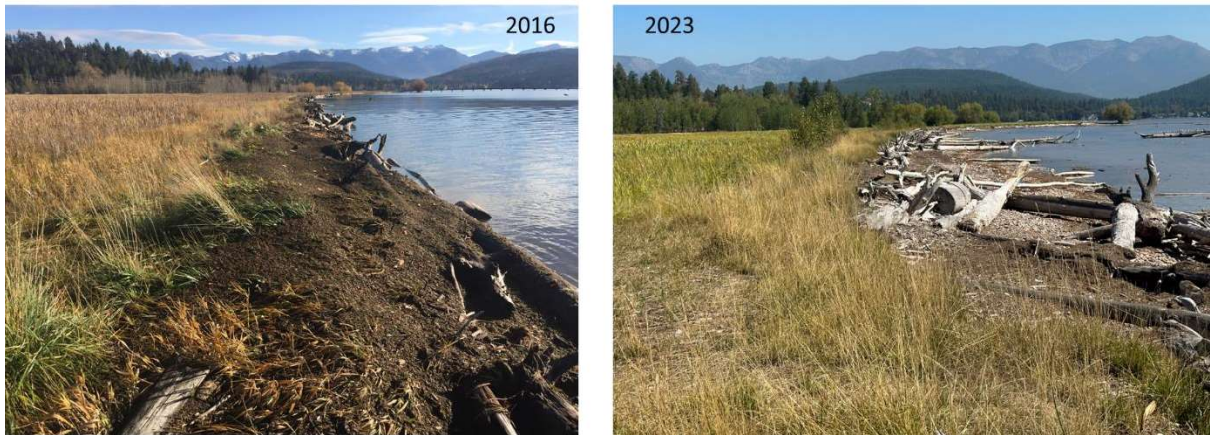
Figure 39. These two photographs compare the shoreline condition from 2016 left panel with 2023 conditions. Larger driftwood has been added and some riparian trees and shrubs have begun to take hold. This gardening process, completed by the waves grinding up the annual supply of logs into woodchips and peat then spreading that material over the gravel beach and into the marsh, is a classic example of the kind of goods and services provided by nature free of charge. The lake level regime between 2016 and 2023 has dramatically helped the gardener resulting in erosion control and shoreline restoration.

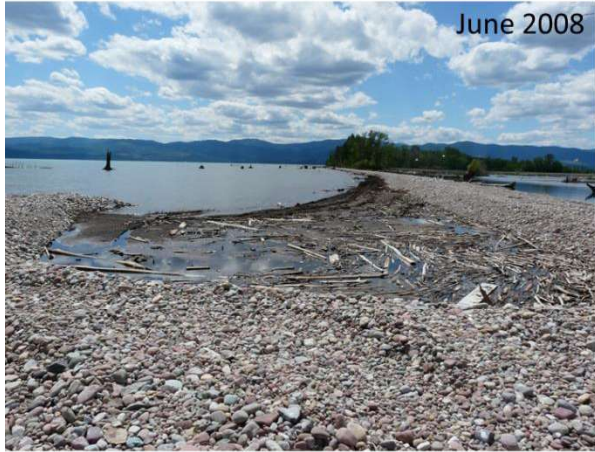
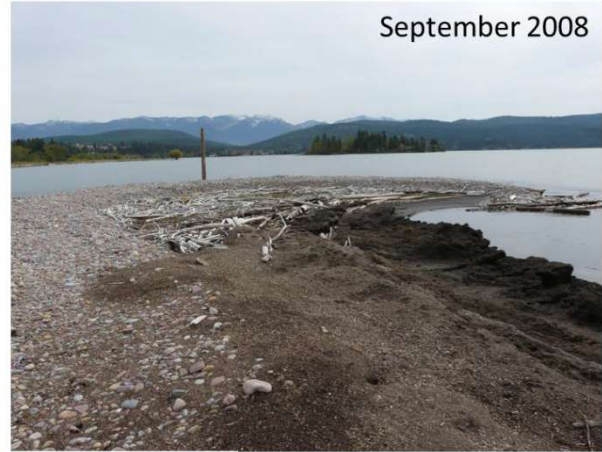
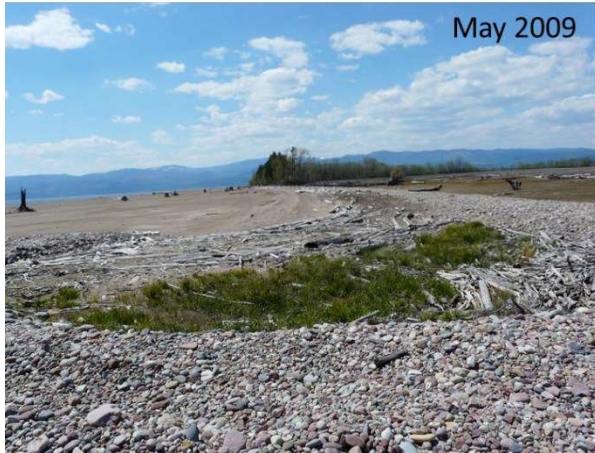
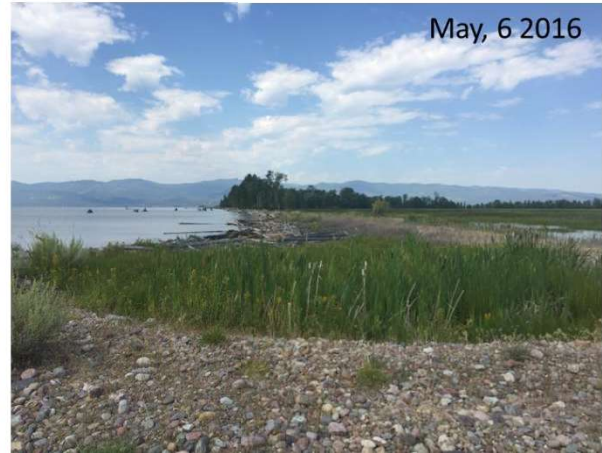
Figure 42. These four photographs show the evolution of the spit embayment from 2008 to 2016. The spit captures wood debris transported along shore by waves completely filling the embayment in the first full pool season.

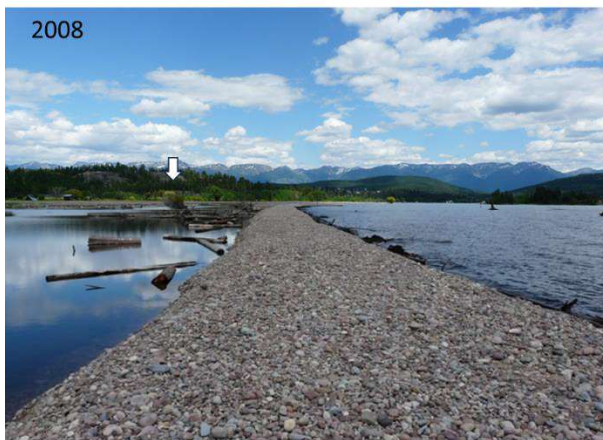
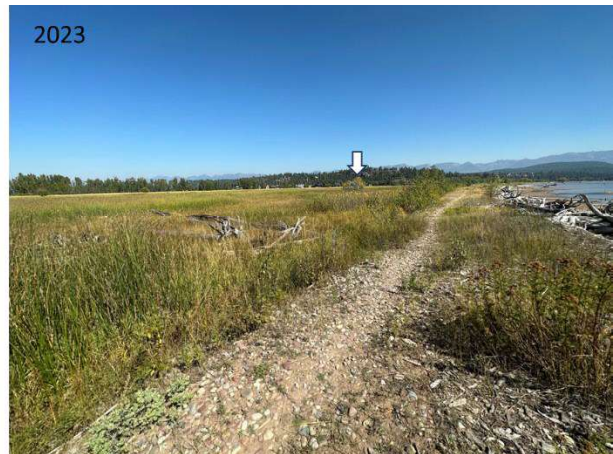
Figure 43. These two photographs show the change between 2008, the first full pool season after the gravel dikes were built, and 2023. The white arrows show the position of the willow that appears in several figures as a reference point. The pond area behind the dike has been revegetated with aquatic and emergent marsh plants.

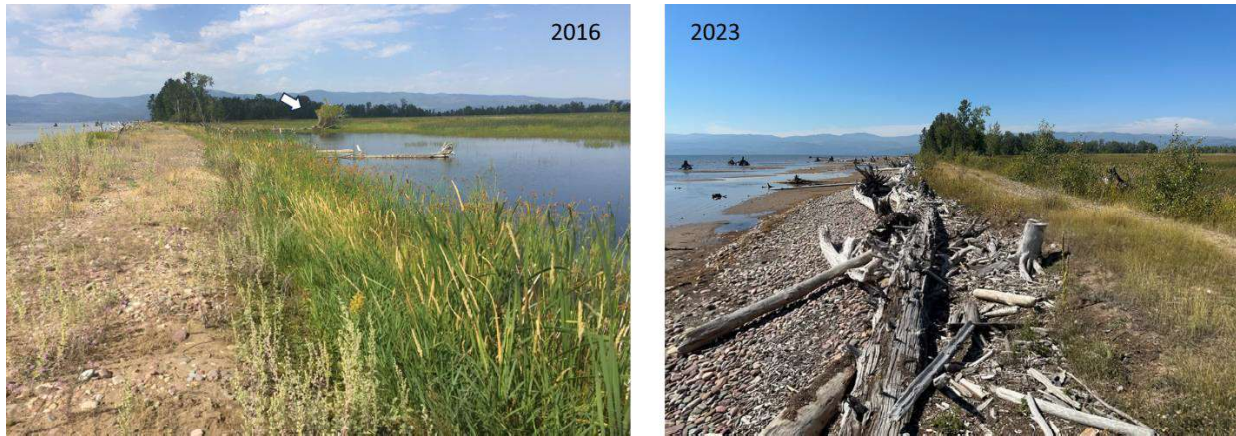
Figure 44. These two photographs together with figure 34 show the change between 2008, the first full pool season after the gravel dikes were built, and 2023. The white arrow shows the position of the willow that appears in several figures as a reference point. The growth of willows and cottonwood trees on the inside of the gravel dike has started the reforestation of the gravel dike. This dike was left to revegetate naturally while the offshore dikes near the river mouth were replanted over most of the dike along the river arm and the spit. This dike would have a more diverse and mature forest had it been replanted with riparian trees and shrubs. Wind blown sand that deposits on top of the gravel helps the natural revegetation process. Foot traffic keeps a path open (Figs, 43 and 44)

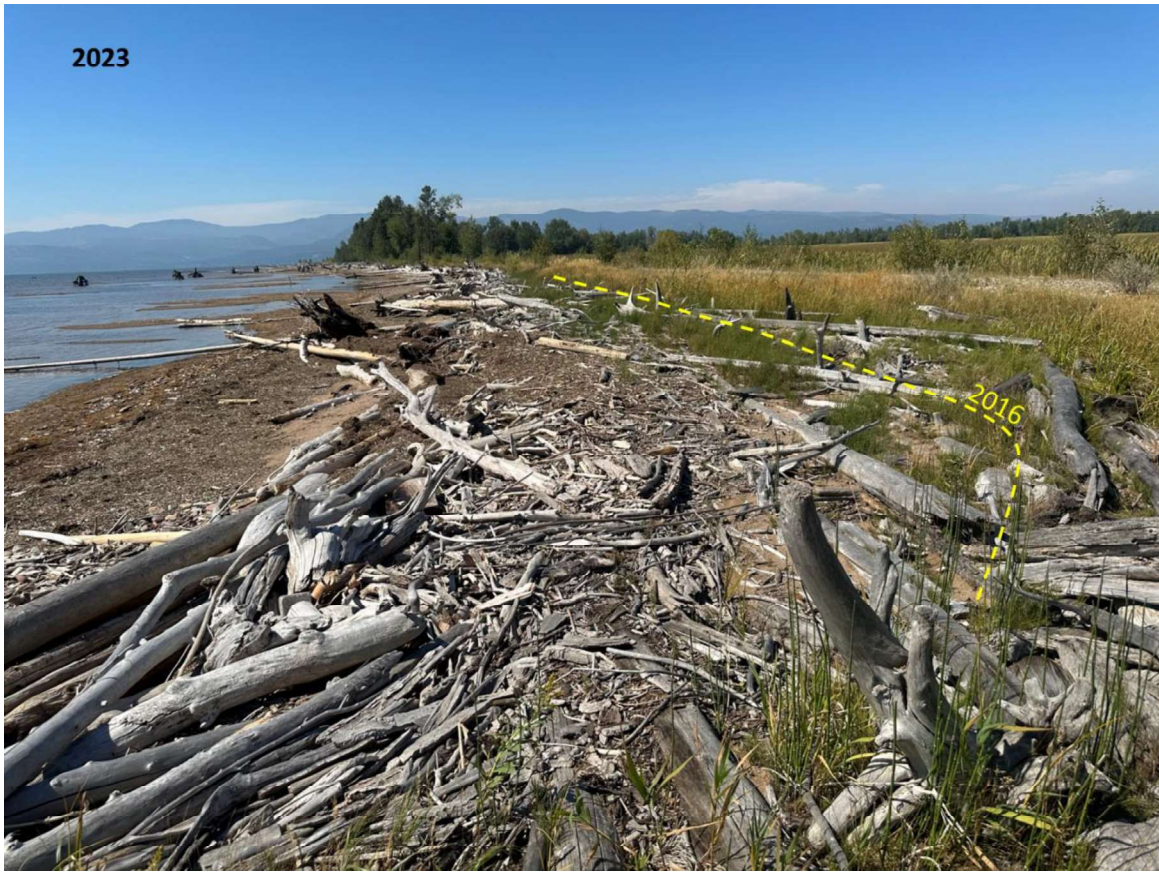
Figure 46. A ground view of the 2023 condition of the lakeward shoreline at the mouth of the spit embayment. Now that the embayment has filled, large wood and peat material bypass the spit on their trek eastward.

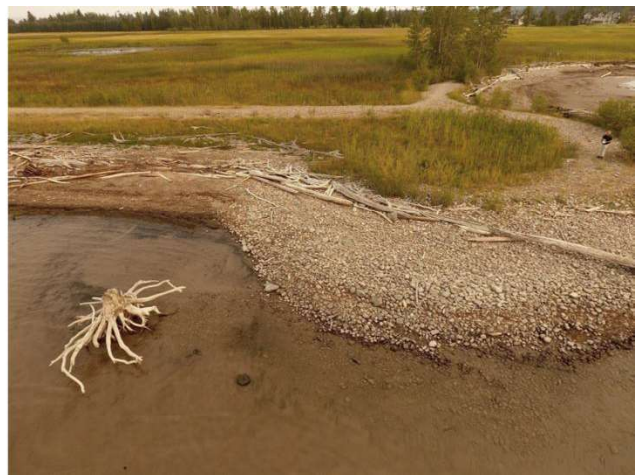
Figure 47. The left panel is a 2023 aerial photograph of the spit with the orange dot indicating the location of the oblique aerial photograph (right panel) of the same area shown in figure 45.

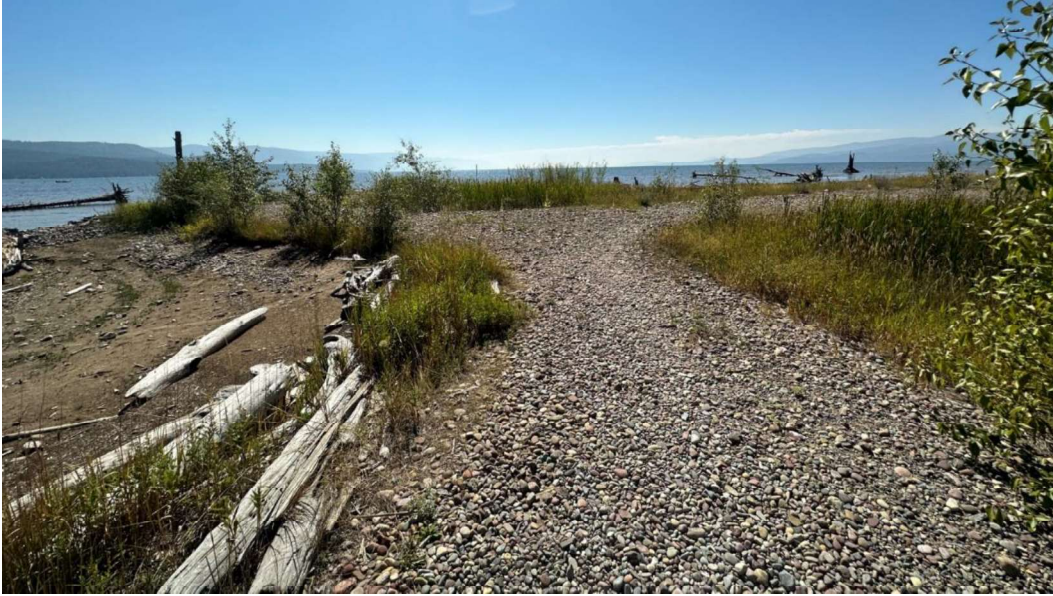
Figure 48. This is a photograph looking south at the gravel beach that connects to the spit. Note the mix of logs-sand and regrowth of riparian shrubs and trees along a specific line and elevation. That elevation is the full pool lake level of 2893 ft.

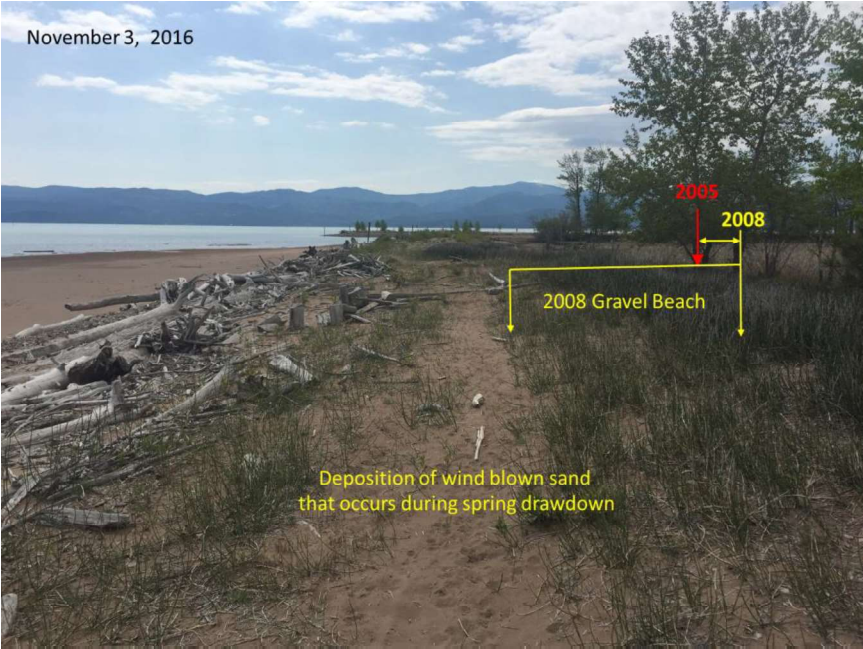
Figure 49. This is a 2016 photograph showing the condition of the shoreline in this area. The deposition of windblown sand and logs followed by riparian succession of plants results in the creation of new, dynamic shoreline habitat. Here the gravel beach is completely buried.

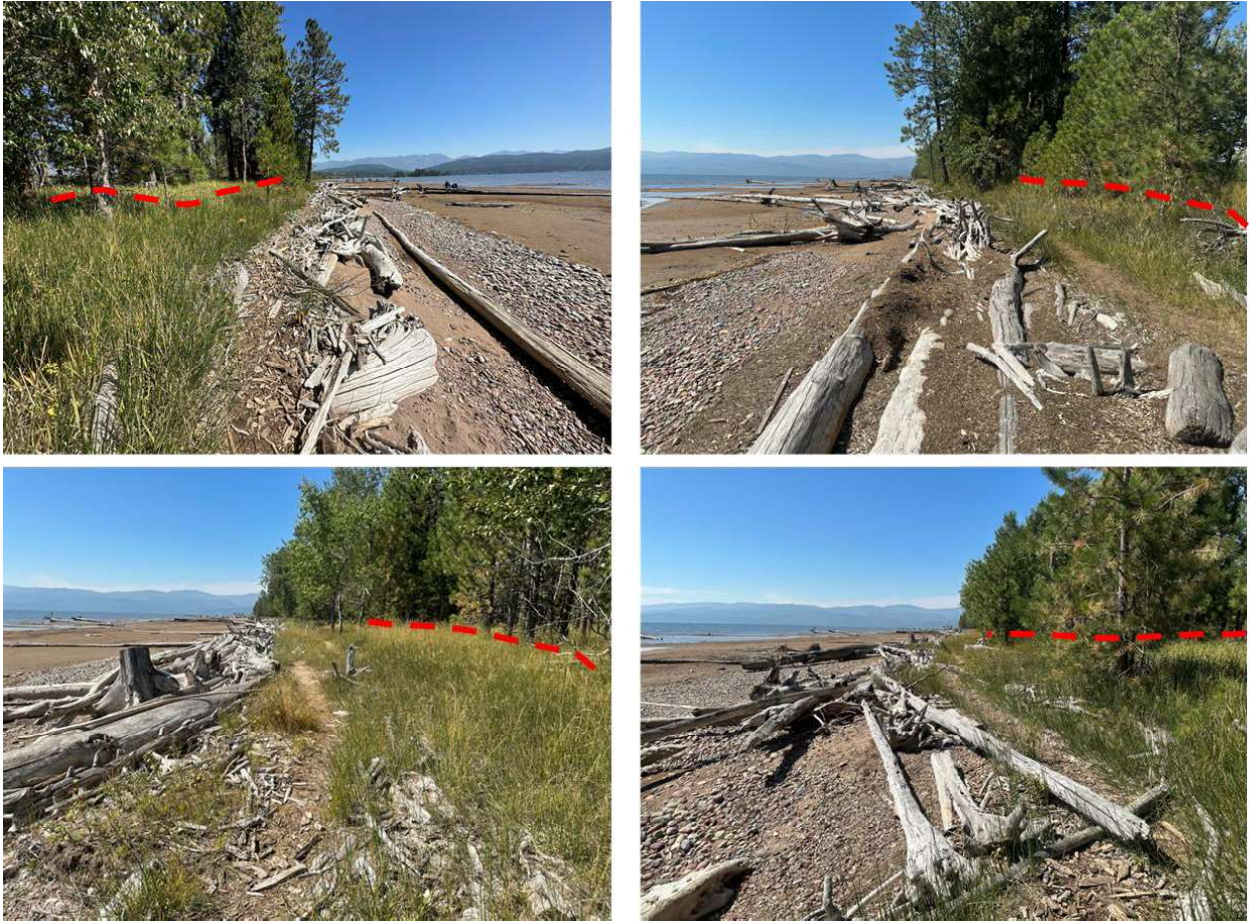
Figure 50. These four photographs show the current 2023 condition of the shoreline on the lakeward side of the eastern WPA. This section of shoreline has been accreting since construction of the shore attached gravel beach in 2008. The deposition of windblown sand and logs followed by riparian succession of plants results in the creation of new, dynamic shoreline habitat. The red dotted lines show the approximate position of the 2005 shoreline.

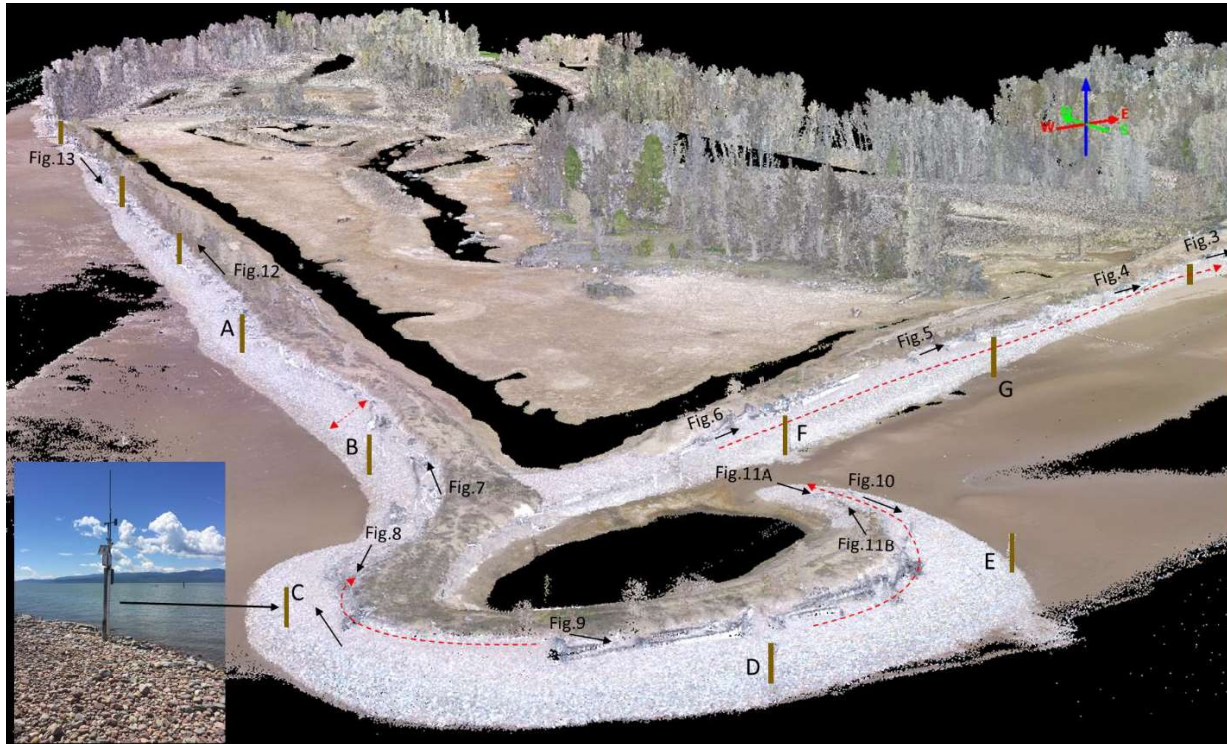
Figure 2. This graphic, from the 2017 final report is a color enhanced, 3D oblique aerial view of the offshore beach and spit just east of the river mouth. This DEM was derived from drone-based LiDAR data and imagery collected May 5th, 2017. The water appears black and the exposed lakebed tan to light brown. The location of pilings driven into the lakebed are shown with labels near those where cross-sectional profiles are compared between May and Oct LiDAR data collections. Location of photographs are shown by corresponding Fig. # with black arrows showing the view orientation. The red dotted lines with arrows show the direction of gravel transport. The photo inset shows the weather station located at piling C.

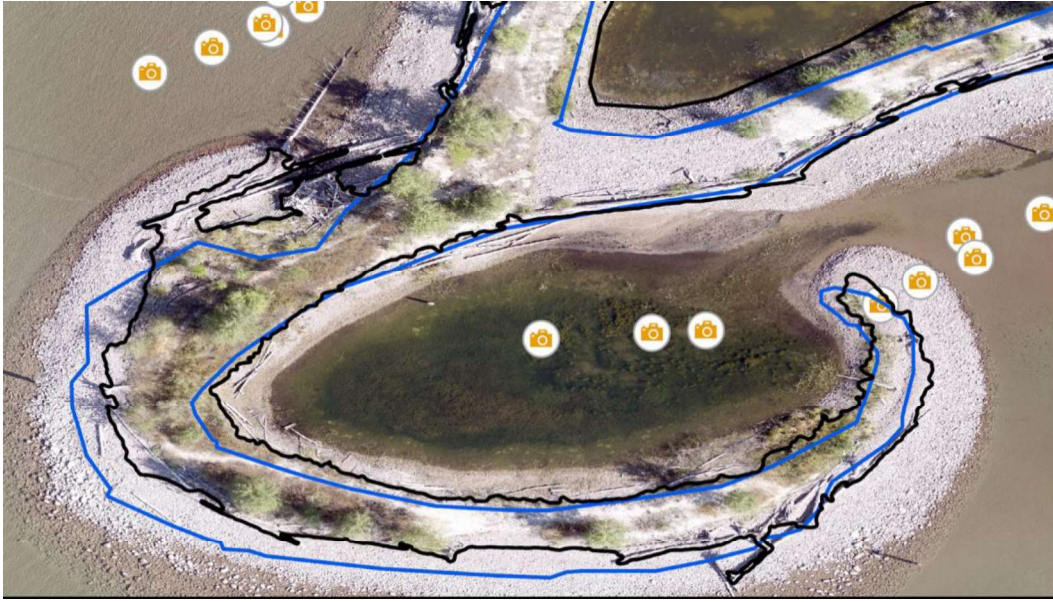
Figure 53. This aerial photograph of the spit embayment shows the extensive regrowth of aquatic plants within the spit embayment. It also shows the areas of erosion and deposition since 2016 on the outer lakeward shoreline (difference between blue 2016 and black 2023 shorelines). The gravel beaches in this area are exposed to the highest levels wave action for the entire WPA constructed shoreline.

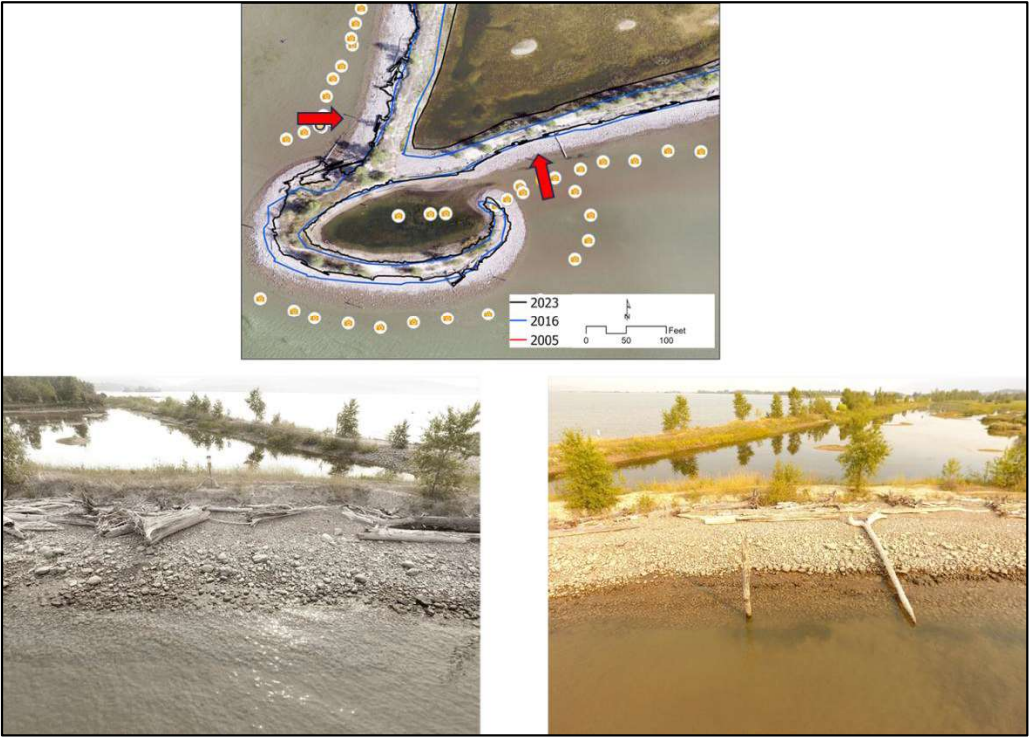
Figure 54. These three aerial photographs show the condition of the lakeward 2023 shoreline on the gravel spit. Piling F is visible in the lower right photo. The left photo is near piling B. Red arrows show photo view orientations.

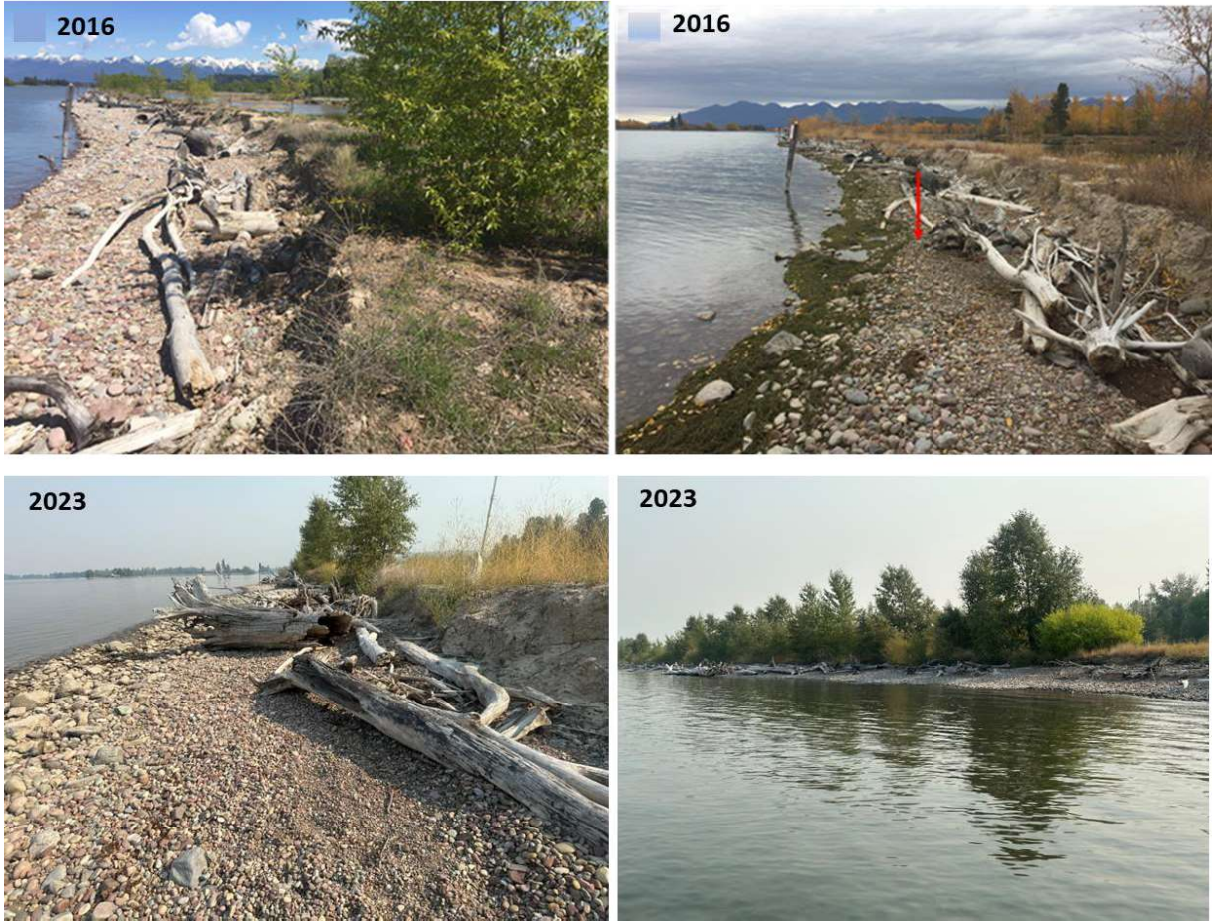
Figure 55. These four ground-based photos compare the change in shoreline condition for the offshore gravel dike and lakeward beaches between 2016 and 2023. The red arrow points to the deposition of aquatic plants by wave action. Although the vertical bank leads one to assume that this area is eroding the actual measured change in shoreline position does not support that assumption. This shoreline is in a state of dynamic equilibrium where waves move and shift the supply of logs and the available gravel creating a shifting habitat mosaic. Leave it alone and if a surface breach occurs here that would be a good thing because it would allow better exchange of water between the lake and the ponds behind the gravel dikes. Piling A can be seen in the top photos.

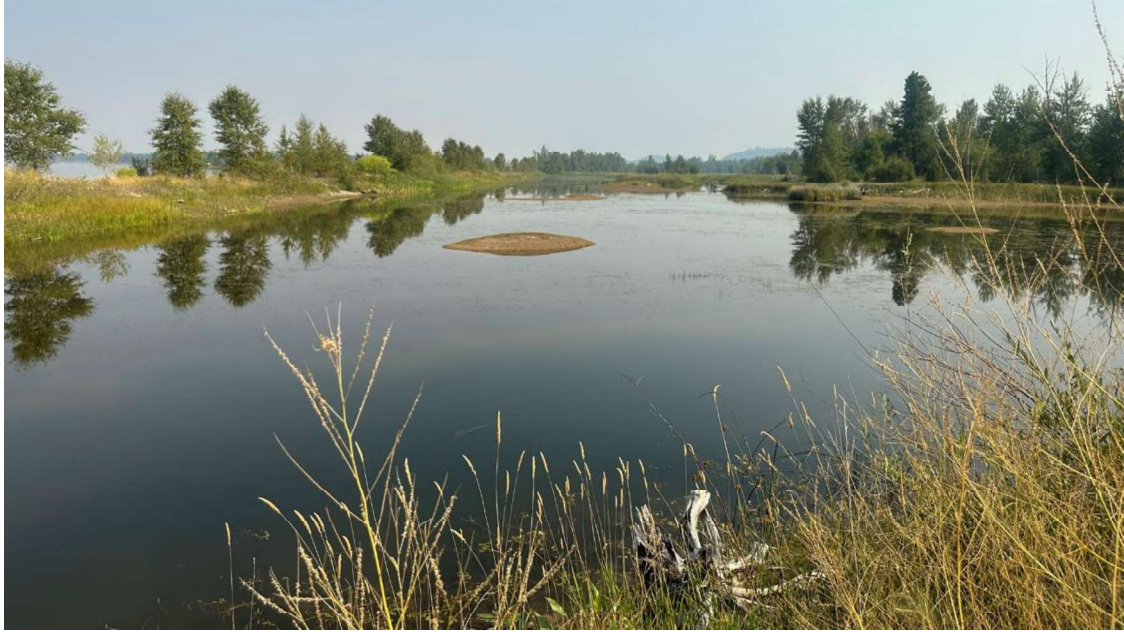
Figure 56. This photograph shows the condition in 2023 of the inside shorelines of the gravel banks. They are very similar to the natural levee banks in this area of the north shore.

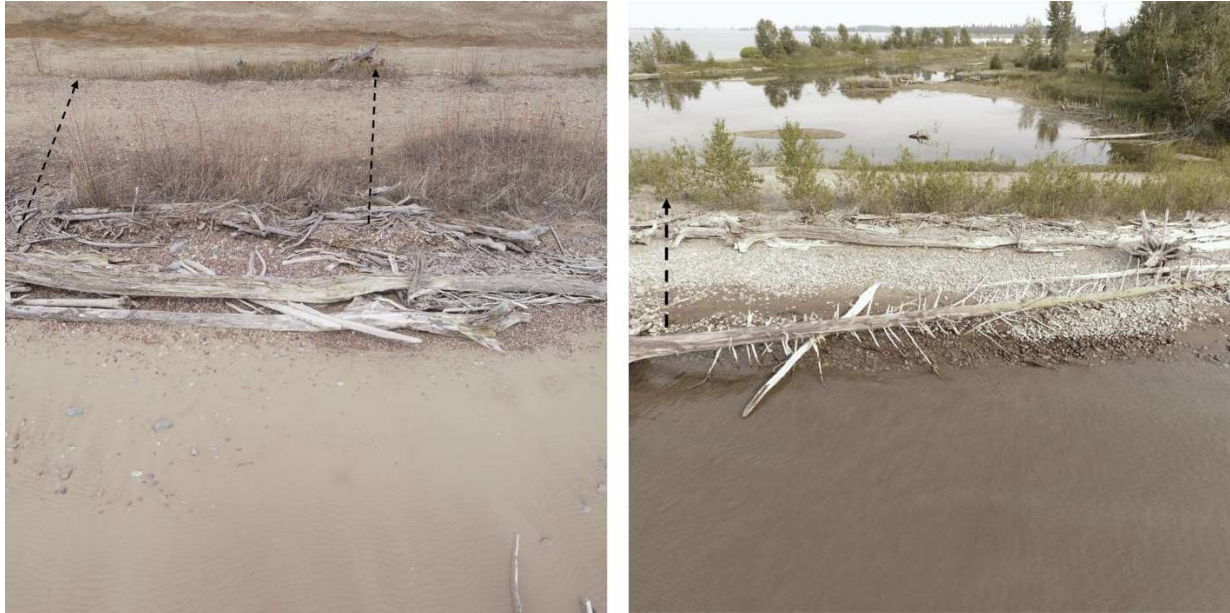
Figure 58. These are oblique drone images between Pilings F and G. The left photo is during lake draw down 2023 and the right photo from same area in August 2023. The black dotted arrows show flow paths from wave overwash.

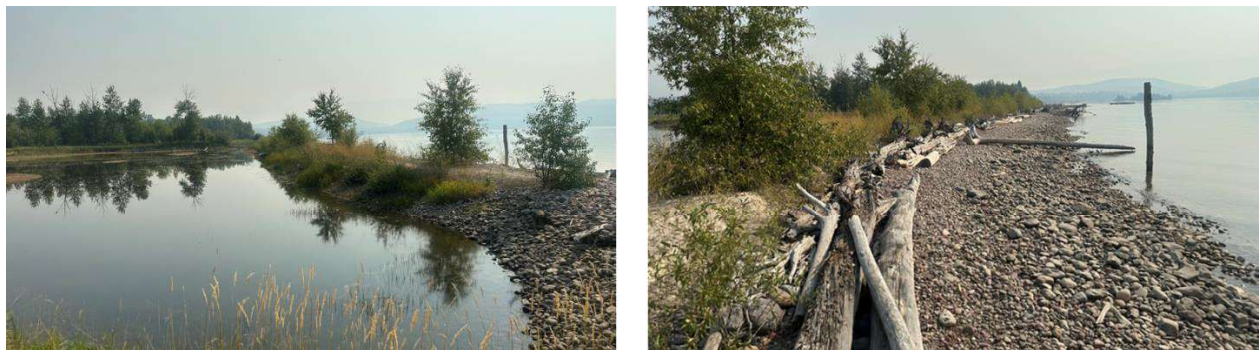
Figure 59. These two photographs show the 2023 shoreline condition of the offshore dike looking east from the spit. The southern wave side maintains a dynamic beach whose job is to extract and absorb all the wave energy (right photo piling G) while the northern pond side is calm enough to allow riparian trees and shrubs revegetate the dike (left photo). Piling G can be seen in both photos. The pilings correspond to transect lines where survey data was extracted from the DEM, and DSM's.

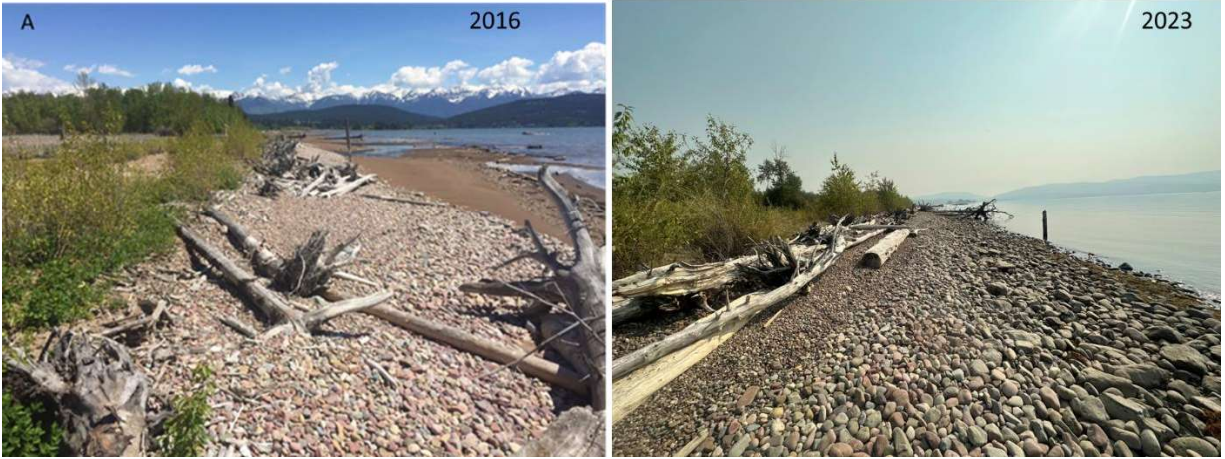
Figure 62. These two photographs compare the shoreline condition of 2016 (left photo) with that of 2023 (right photo) near transect G.

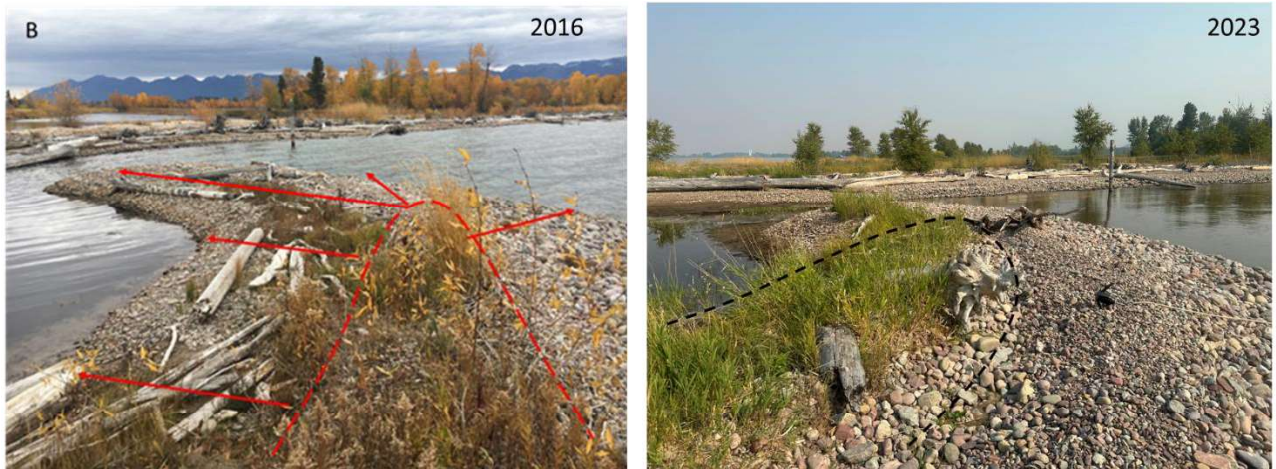
Figure 63. These two photographs compare the shoreline condition of 2016 (left photo) with that of 2023 (right photo) near transects F and G.

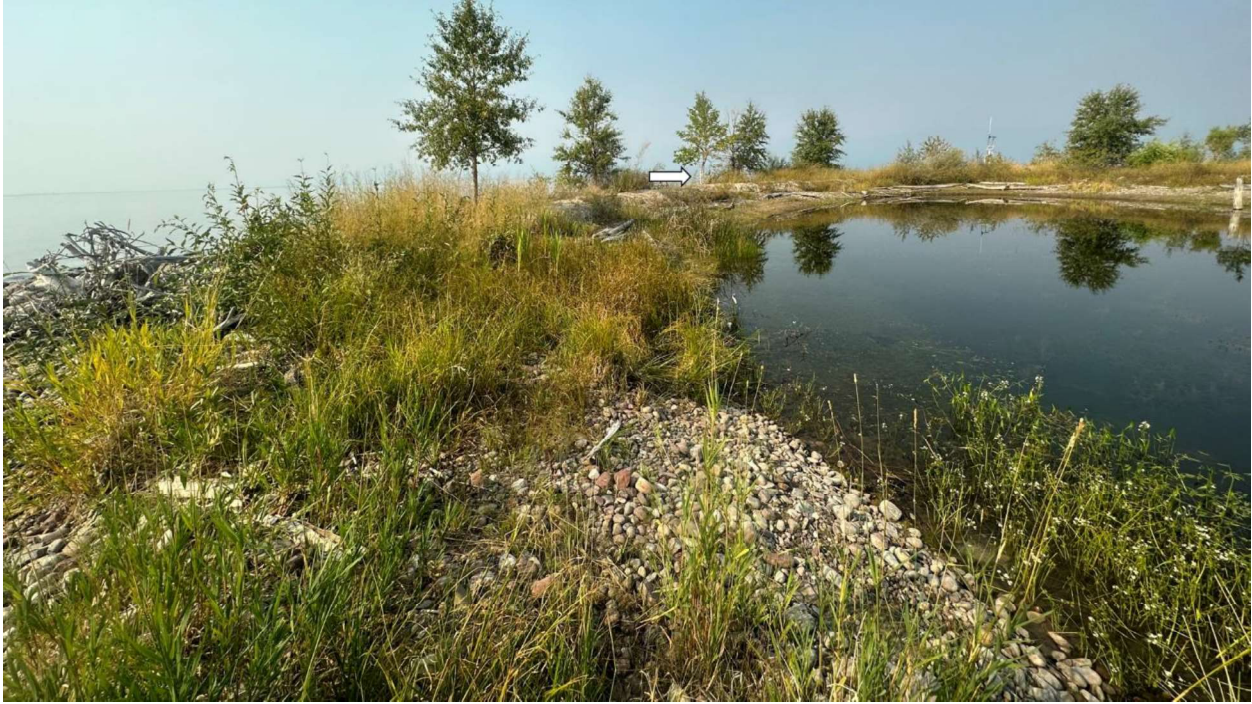
Figure 65. This photograph shows the condition of the 2023 backshore of the gravel dike and spit embayment. The white arrow shows figure 64 view where a break could happen as described in the figure 64 legend.

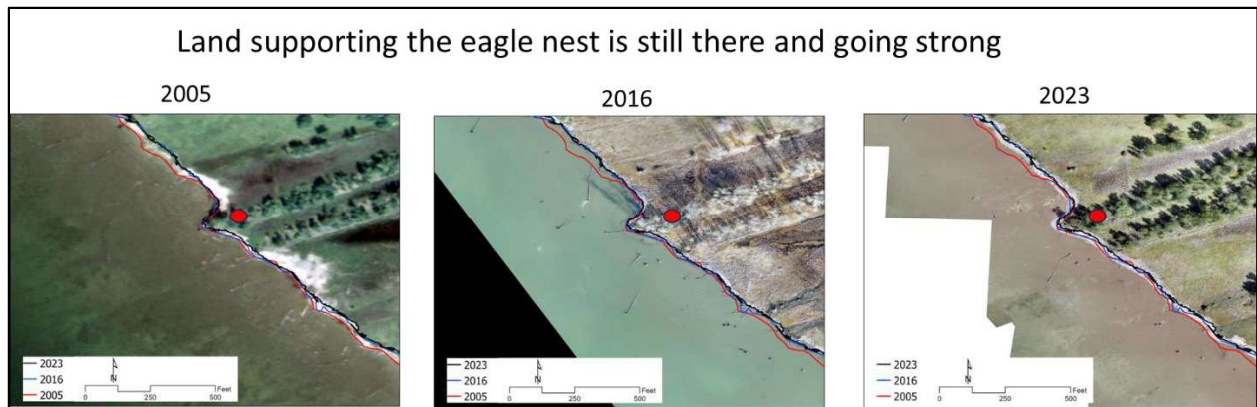
Figure 68. These two panel maps show the stability of the shoreline over time around concern regarding the eagle nest (red dot) in this area.
